National
Trust

Case Study

Sizergh Castle

Heavy summer rain
flooded multiple areas
of the estate

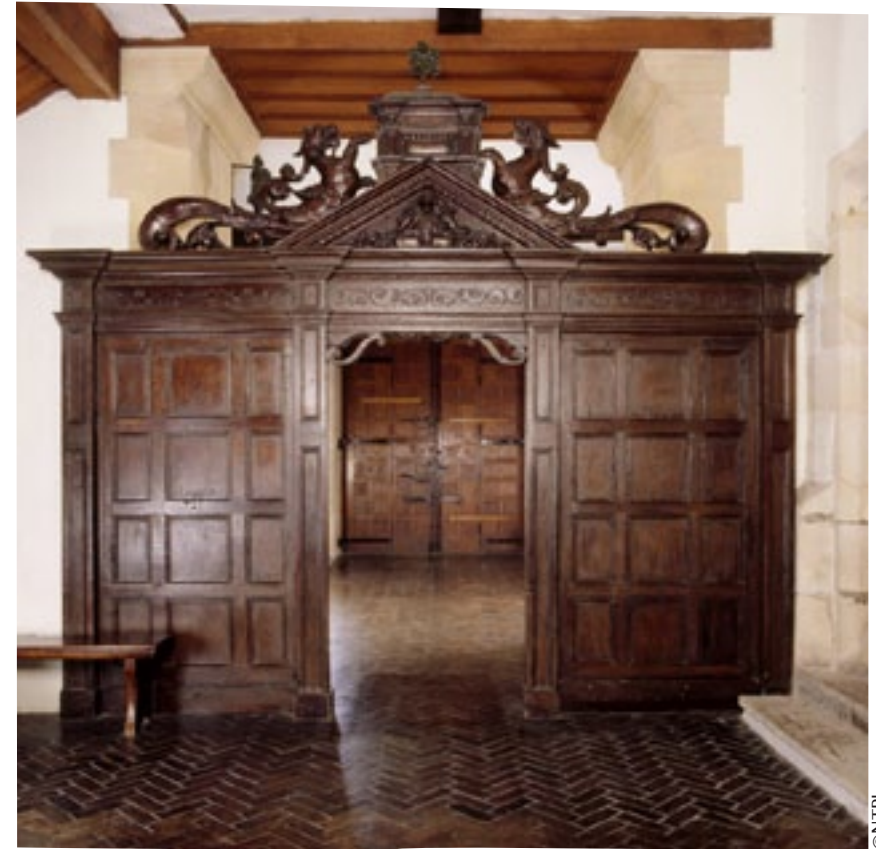
Above **The Entrance Hall** at Sizergh Castle

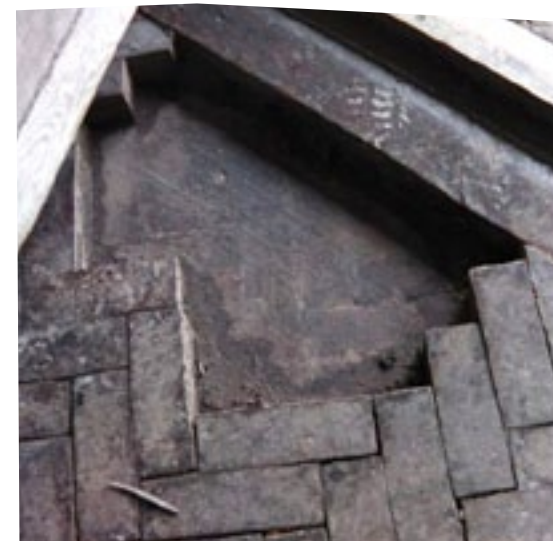
The greatest damage in the castle occurred to the oak wood block floors in the Entrance Hall. A few of the blocks were displaced in the flood and were discovered floating in the floodwater. All of the floor blocks were removed to be salvaged, but not all could be recovered. All of the original adhesive on the wood oak blocks was also lost due to the flood and salvaging process.

Left **Part of the Entrance Hall** wooden floor, damaged

A few of the oak blocks had been too damaged to restore and some new oak wooden floor blocks were made in their place. All of the wooden blocks needed new adhesive and a modern version needed to be implemented because a replica of the old bitumen adhesive was not setting. Once the new adhesive was added the wooden blocks were placed back in the Entrance Hall floor according to their identification labels.

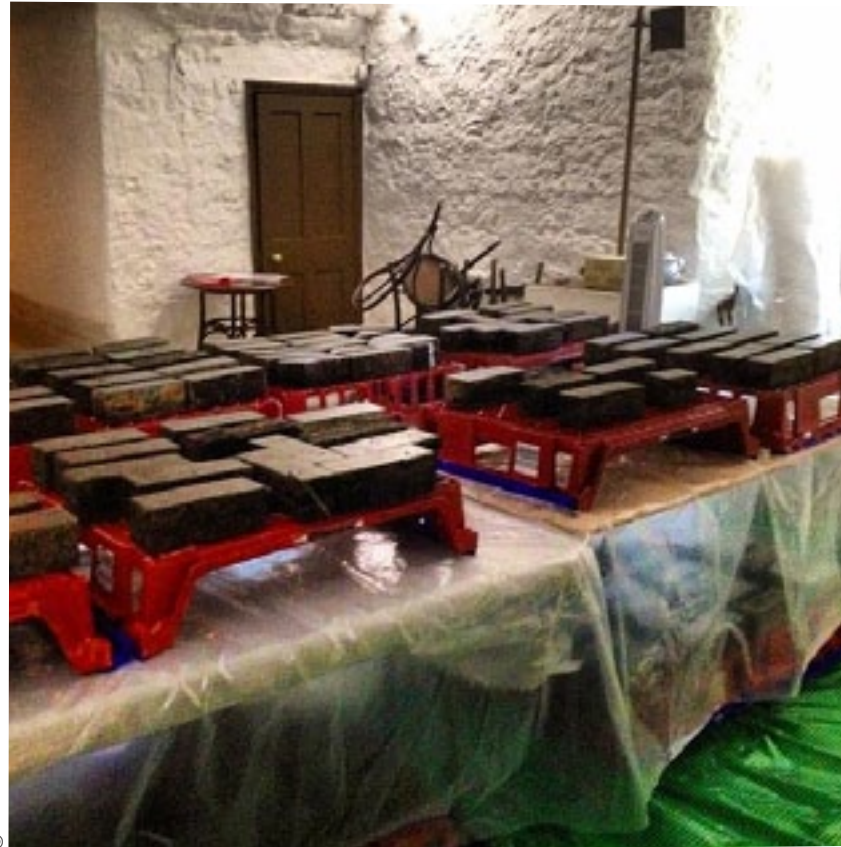
Top left **Wooden floor blocks drying out in the salvage room**

The following day National Trust Conservator Julie Vint and Furniture Conservator (Peter Hall & Sons) John Wynn Griffiths came to assist the salvage and assess the damage to the floor. Peter Hall & Sons visited again many times over the coming weeks. The wooden floor blocks were dried in the wind tunnel in the basement of the castle, during which the humidity levels were constantly measured and maintained.

Drying couldn't occur too quickly to prevent further damage to the oak blocks. With this technique the wooden blocks needed 4 – 5 weeks to dry completely. Afterwards the floor blocks were all cleaned; old fill and bitumen was completely removed from the bottom and sides of the blocks.

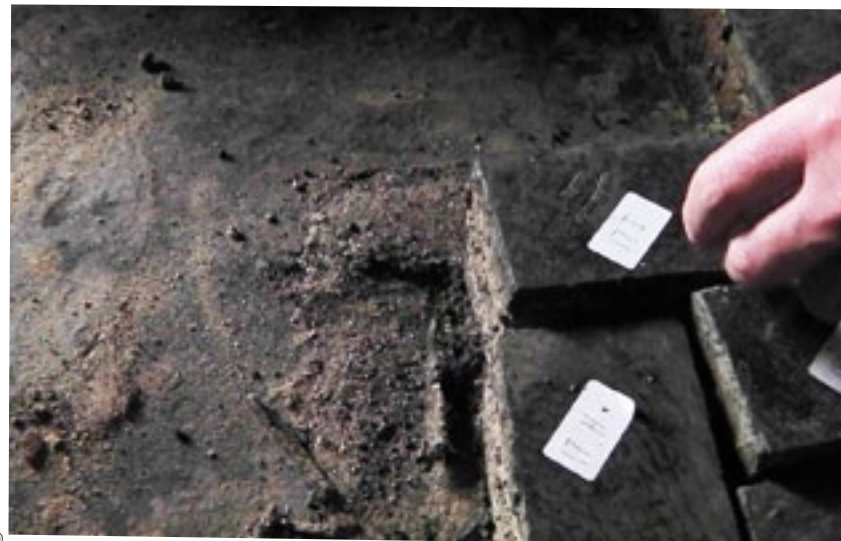
Bottom left **Oak blocks are labelled to recognize their original positions**

Staff then began to salvage the items from the Entrance Hall. Each wooden block was labelled to preserve its original location and removed from the floor on Thursday afternoon. Every single oak block removed (over 2000 in total) was then placed in the wind tunnel in the salvage room. All of the heavy furniture in the Entrance Hall was raised off the ground and placed on standing blocks. The items which hung on the walls such as the aboriginal spears and shields as well as chairs and taxidermy cases were repositioned in the Queen's Room and Dining Room on the first floor. No other items needed any additional conservation work.

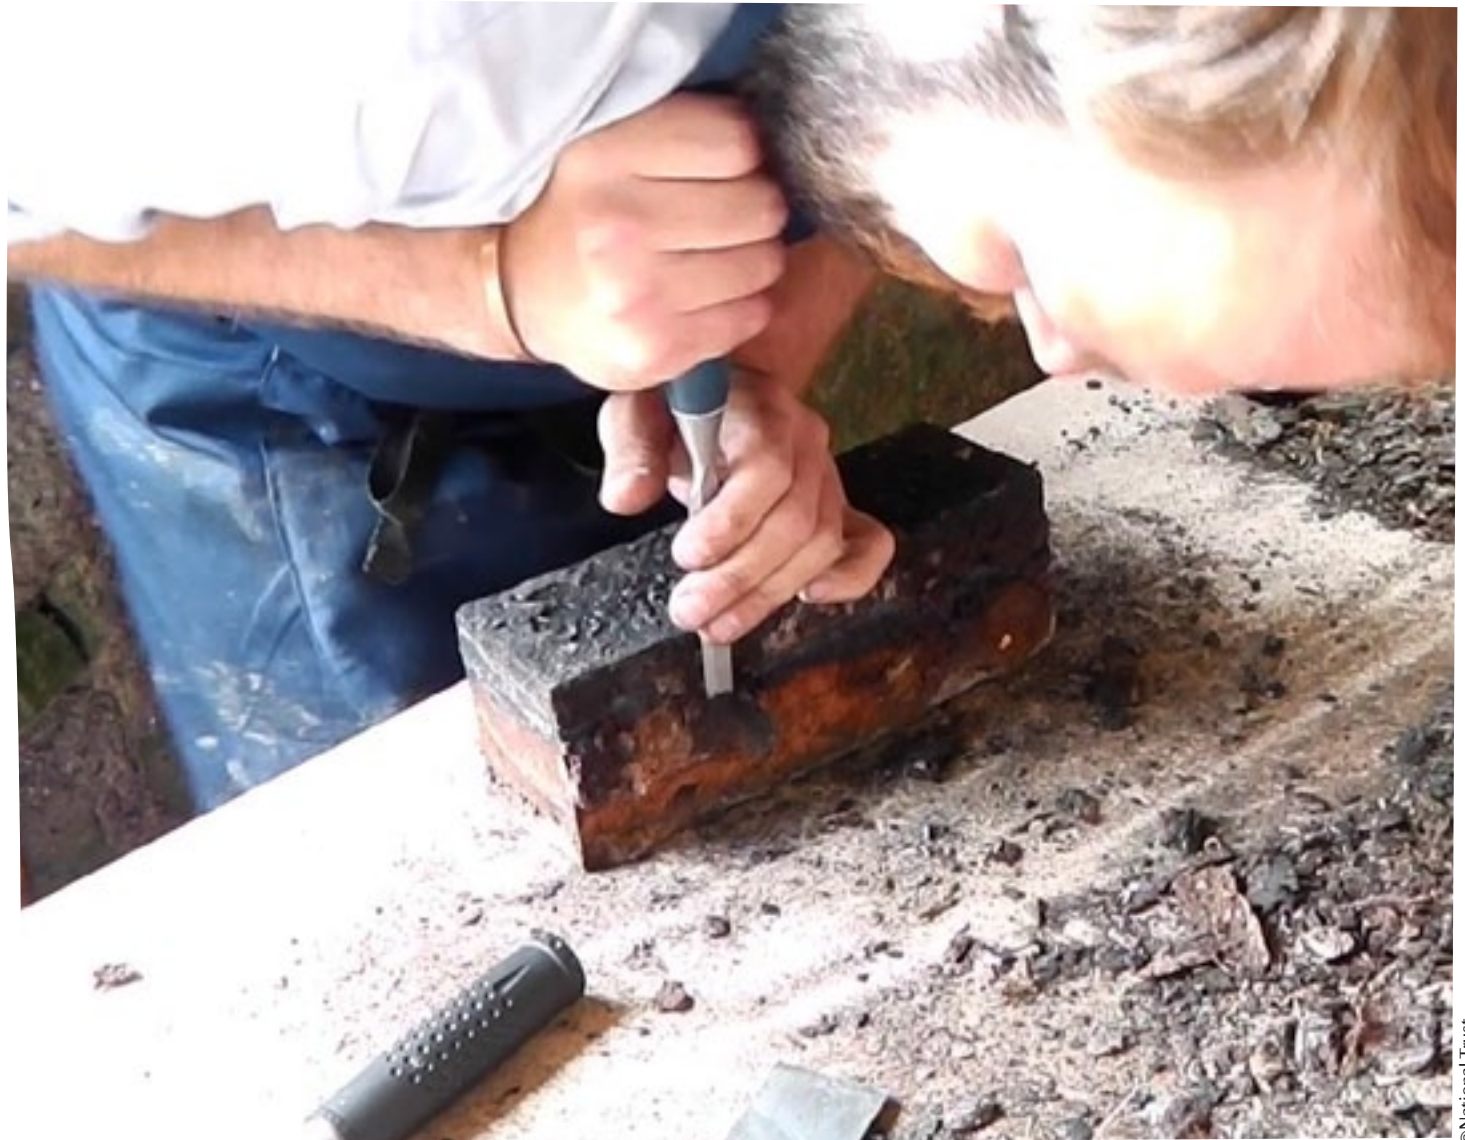
Right Oak blocks being cleaned before relaying

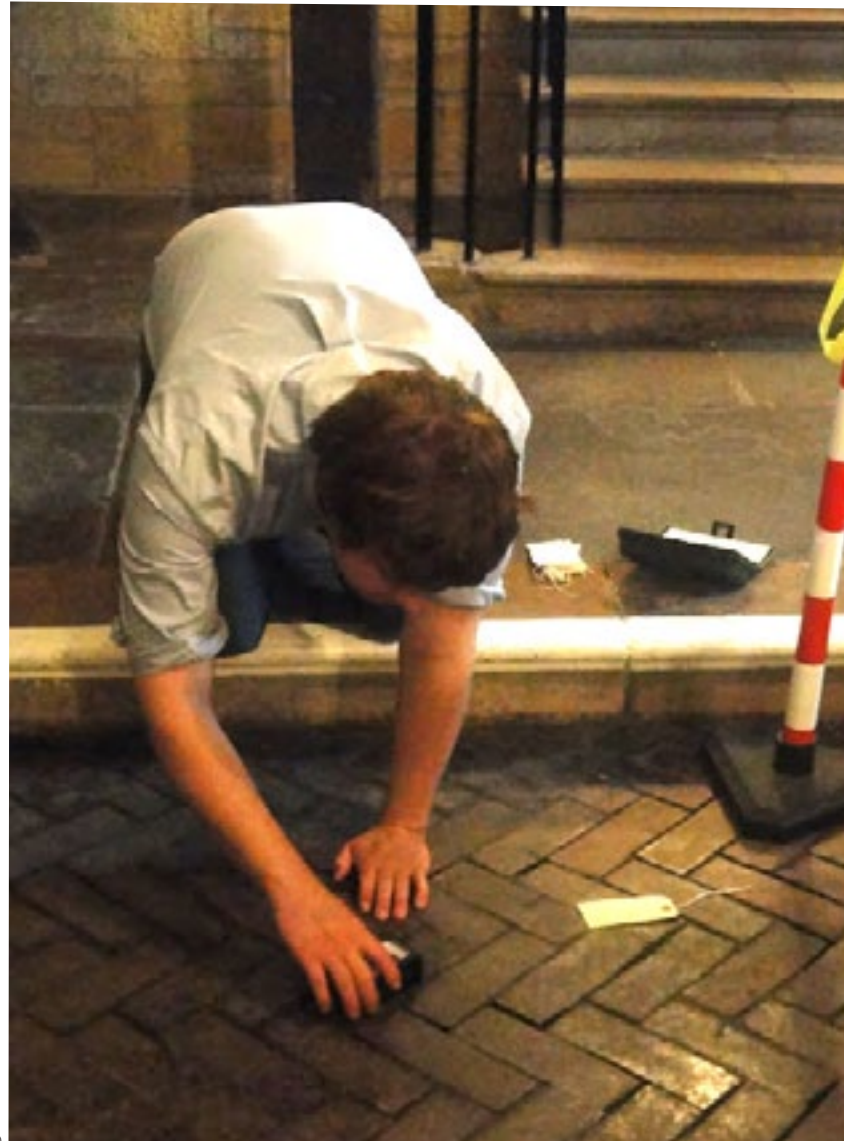
Left Replacing the wooden floor blocks after drying and cleaning

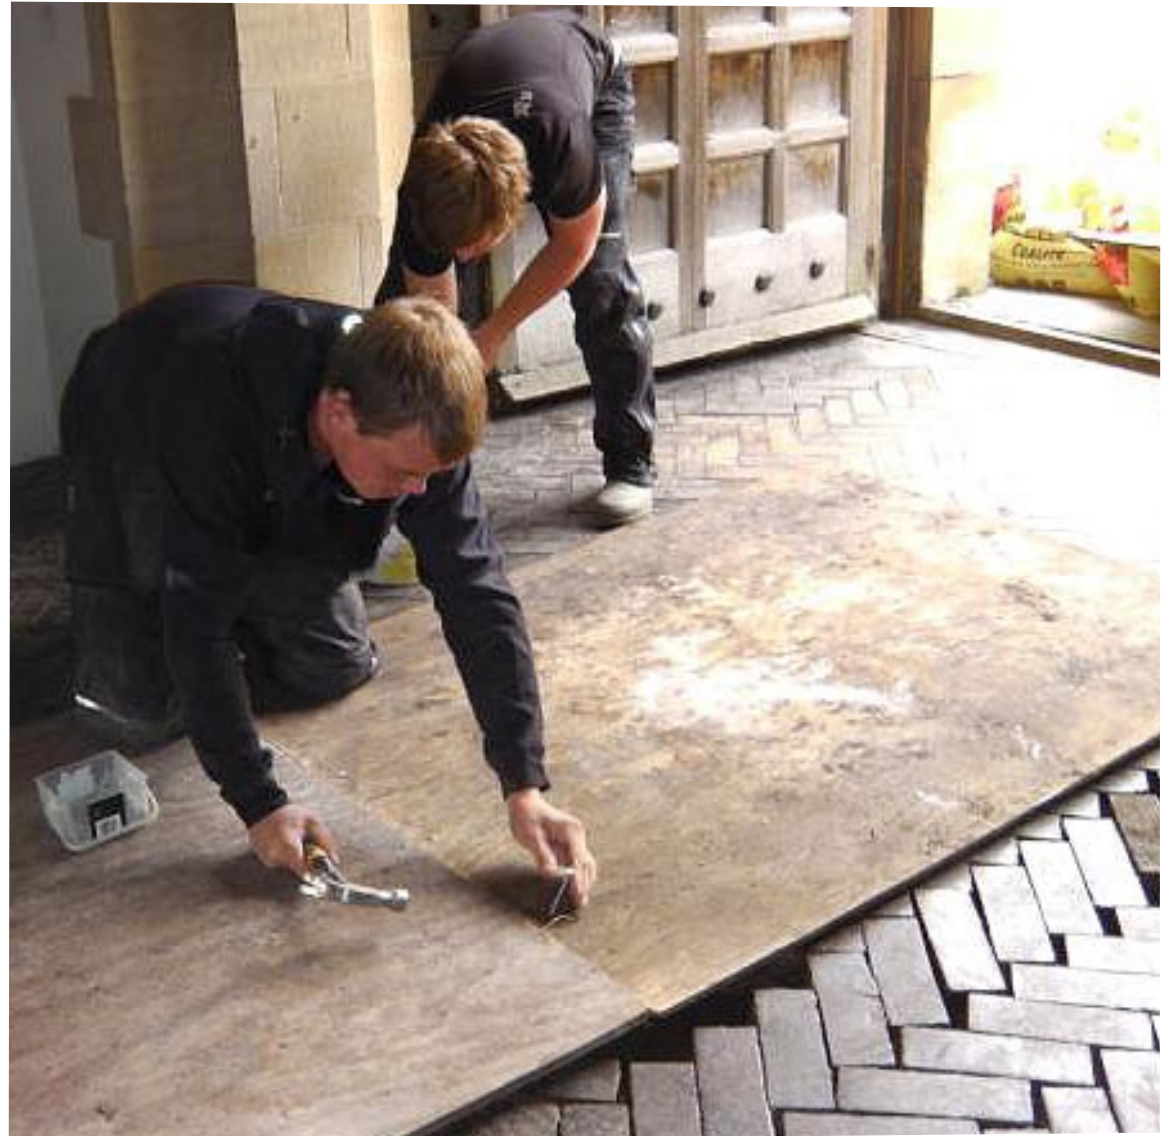
Above [Installing the temporary floor](#)

During the restoration floor protection was set up in the Entrance Hall and works continued to be carried out during visitor hours. Interpretation panels were set up to inform the visitors of the ongoing conservation work.
