**A MANUAL ON CONSERVATION
METHODOLOGY
FOR HISTORIC BUILDINGS & STRUCTURES**

Puerto Rico and the Virgin Islands

US Department of the Interior
National Park Service
National Center for
Preservation Technology and Training
Publication No. 1997-07

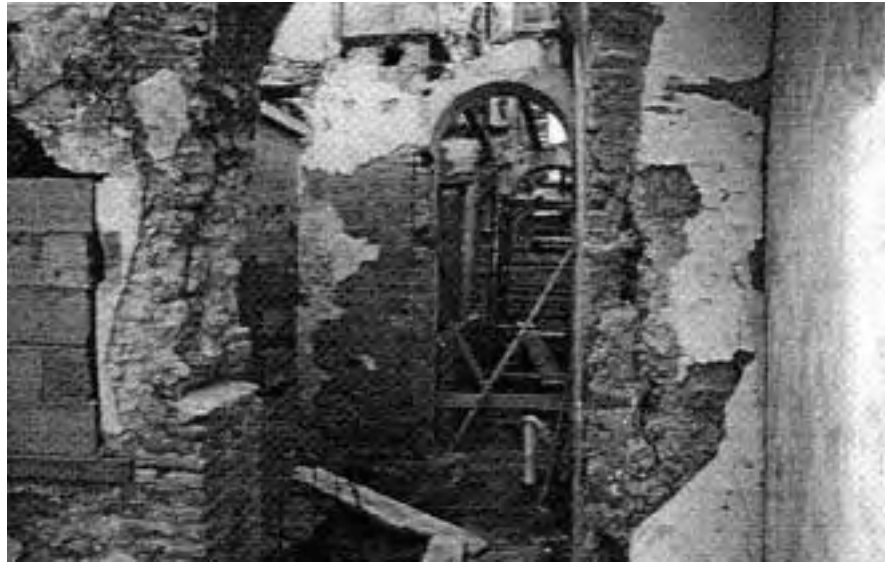
Deterioration caused by the use of incompatible construction materials such as modern concrete block inserted into rubble-masonry fabric.

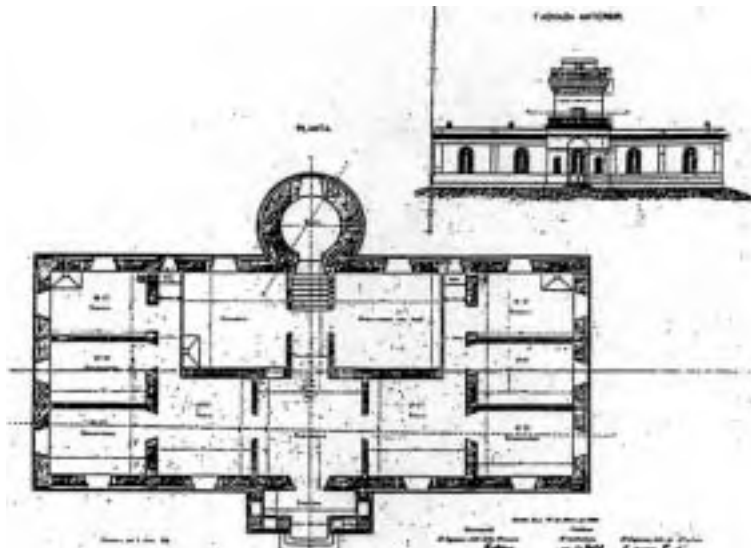
Floor plan and front facade of Las Cabezas de San Juan Lighthouse (1881) at Fajardo, PR (AHN)

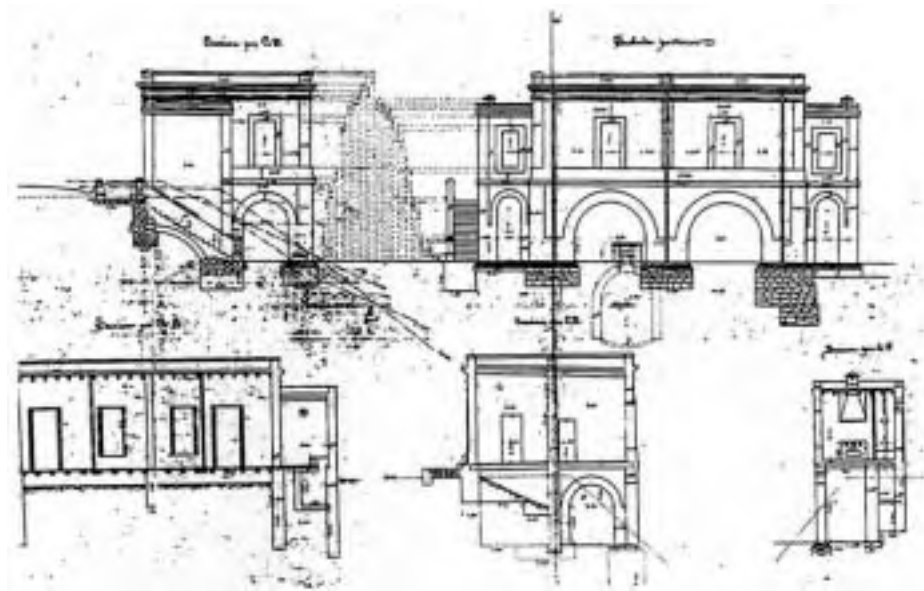
Partial drawings for “Casilla para Peón Caninero” (road maintenance workmen house) at state road #4 (1894) in Jajome, PR. (AGPR)

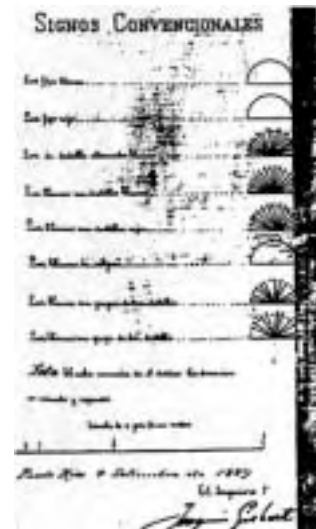
Conventional signs for different lighthouses in Puerto Rico (1889) (AHN).

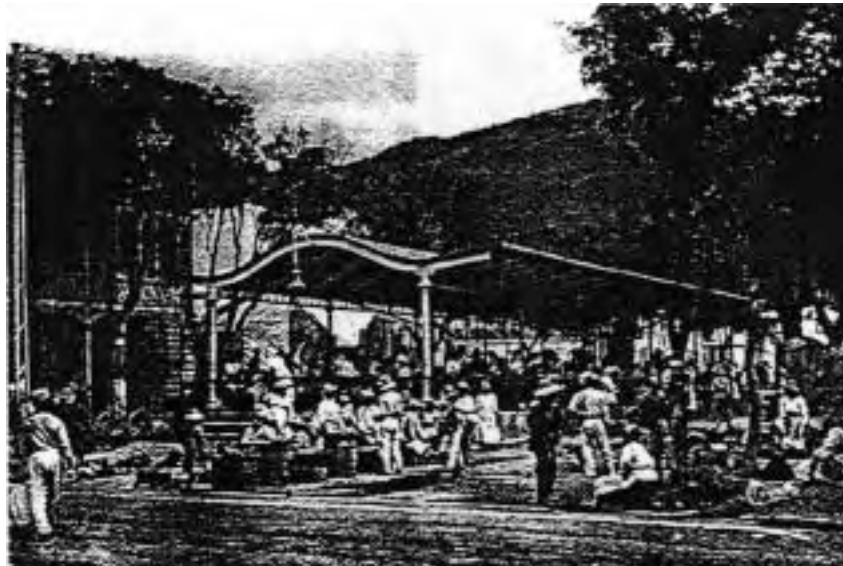
Cast-iron marketplace in Charlotte Amalie, USVI (late 19th century)

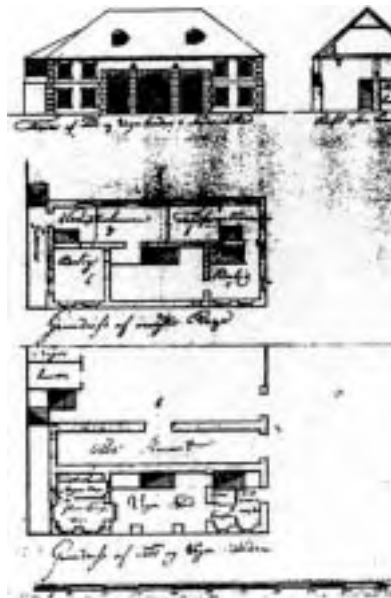
Plans for Customs Toll-House in Frederiksted (ca. 1780) St. Croix, USVI (Rigsarkivet, Copenhagen)

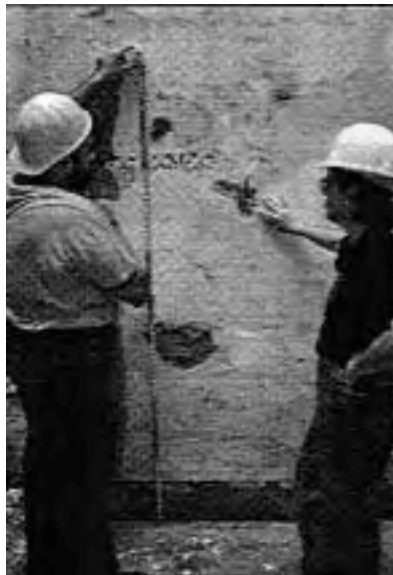
Photographic documentation of historic wall stencils at Casa Ramón Power y Giralt(1992),Old San Juan, PR

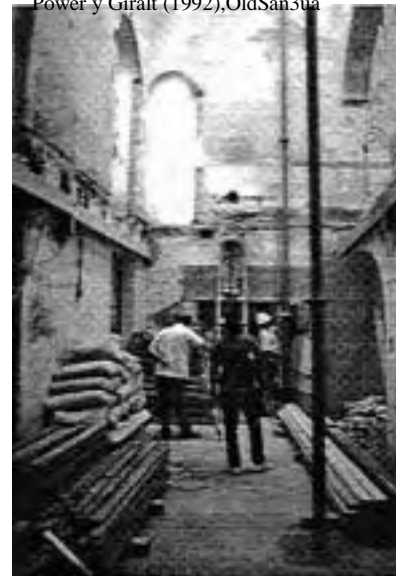
Surveying of elevations during documentation process at Casa Rernón Power y Giralt (1992),OldSan3ua

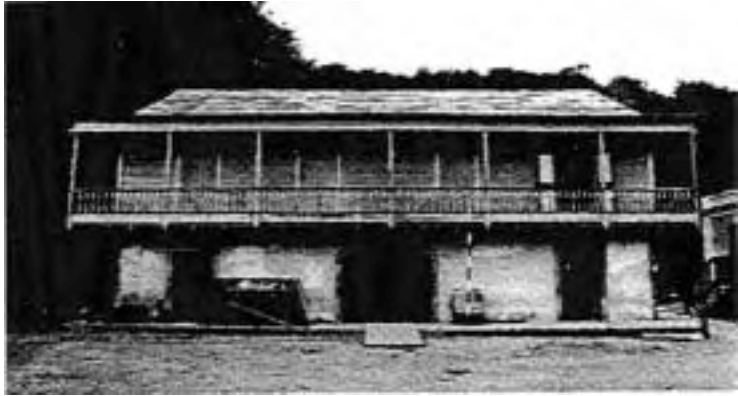
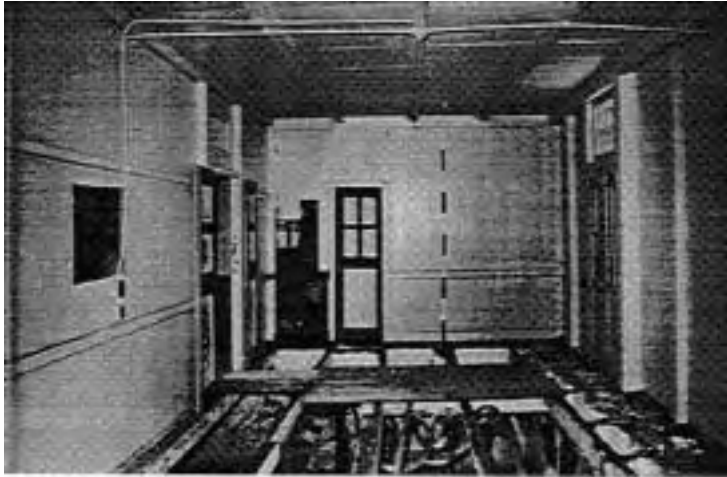
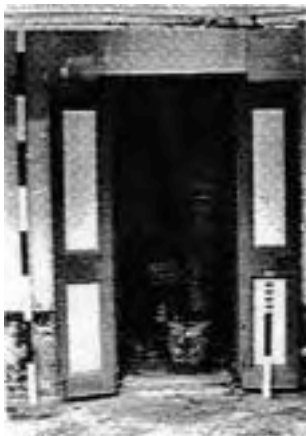
Photographic documentation at Hacienda Buena Vista (1986) Ponce, PR.

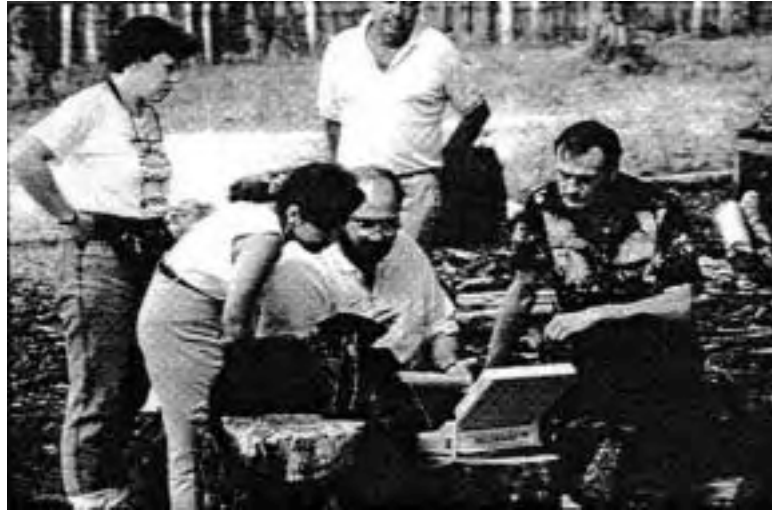
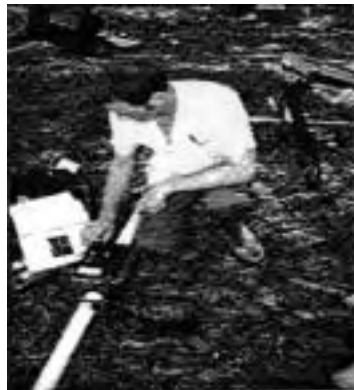
Use of remote sensing equipment to detect the location of buried wells and floors. (Orinoco Project 1994)

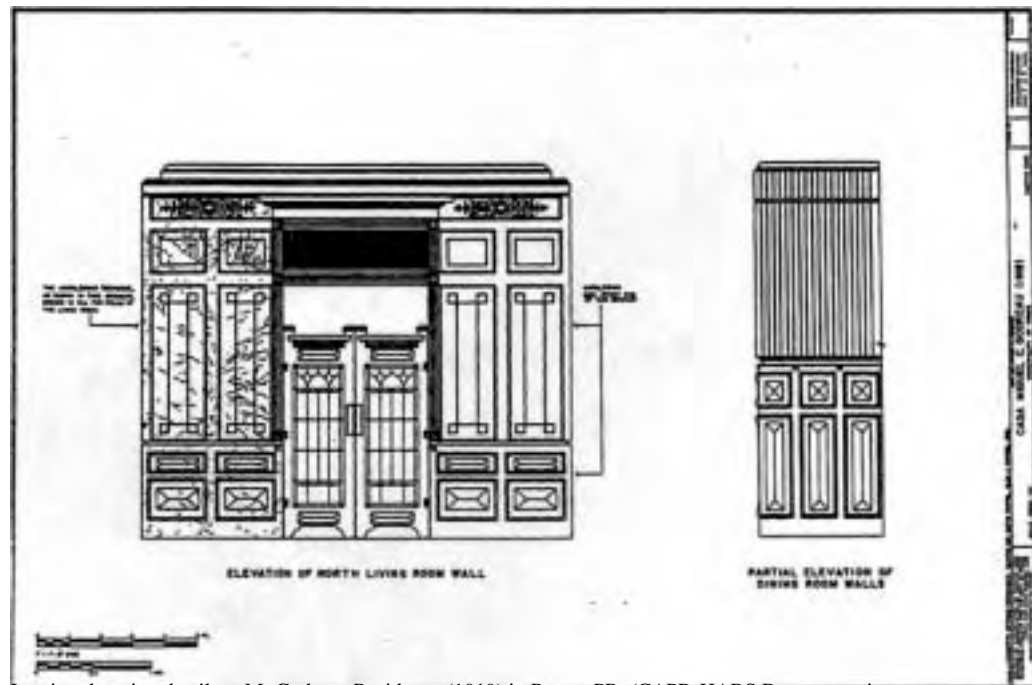
Interior elevation details at M. Godreau Residence (1919) in Ponce, PR. (CAPR-HABS Documentation Project 1985)

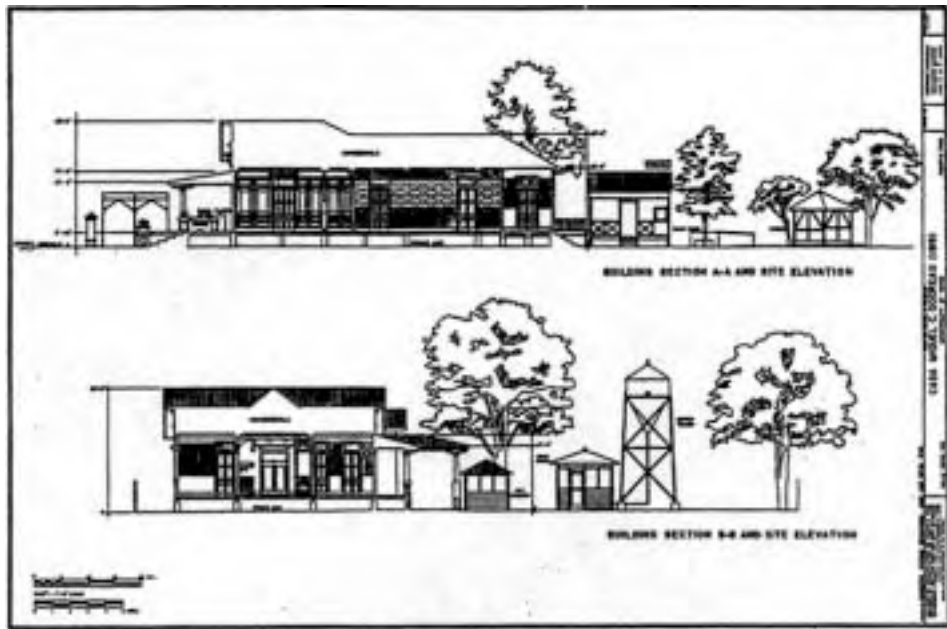
Site sections of the M. Godreau Residence (1919) in Ponce, PR. (CAPR-HABS Documentation Project, 1985)

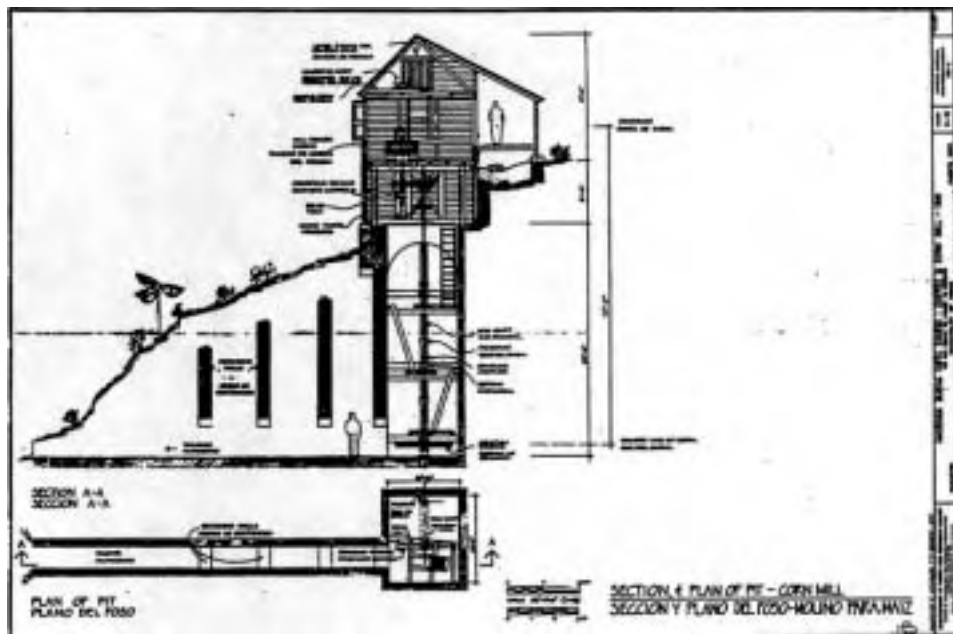
Corn Mill drawings of Hacienda Buena Vista (1851) in Ponce, PR. (HAER, 1977)

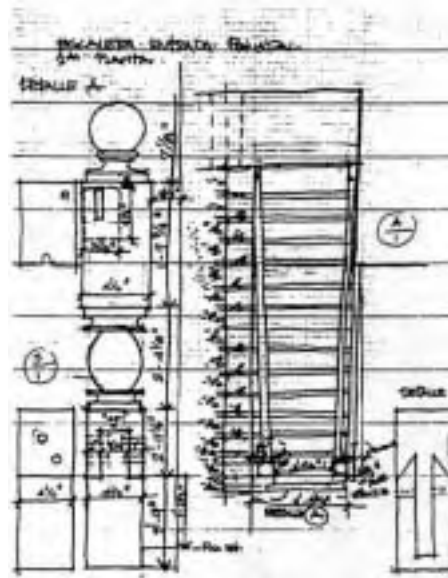
Field notes of entrance staircase. Hacienda 3uena Vista (1851) in Ponce, PR. (HAER 1986)

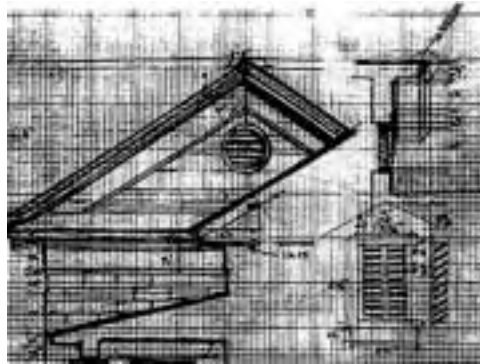
Field notes of Colegio de Arquitectos proposed headquarters in Santurce, PR. (HABS 1990)

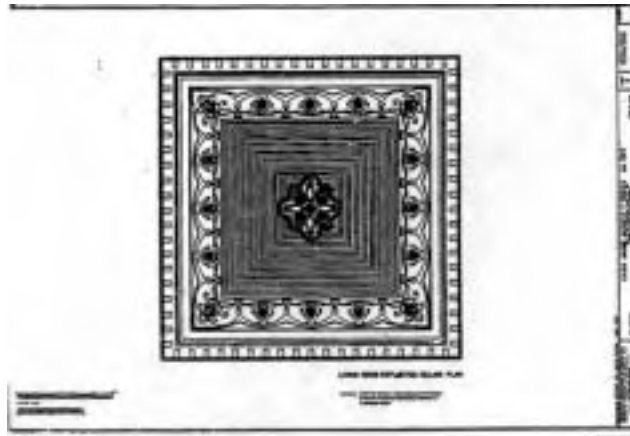
Reflected ceiling plan J. Acosta Forés Residence (1917) in San German, PR. (CAPR-HABS Documentation Project 1983)

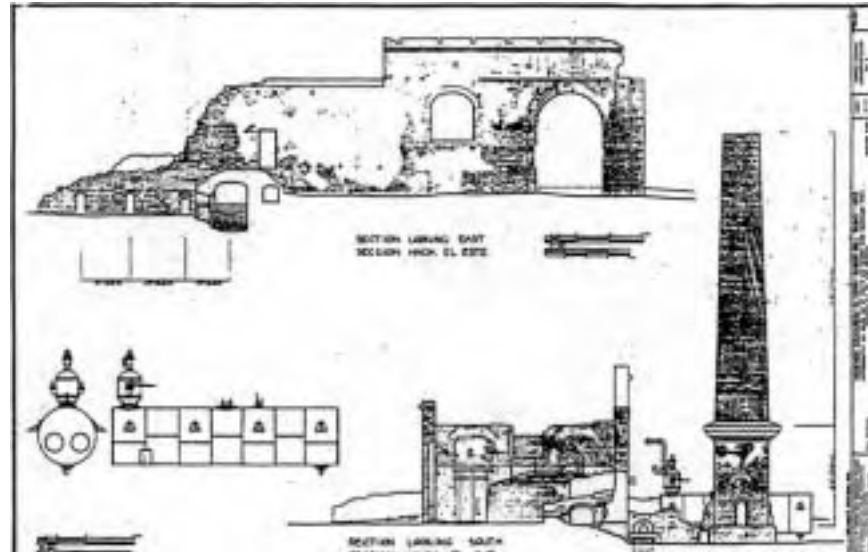
Sugar mill ruins at Hacienda Coto (1852) in San German, PR. (HAER 1976)

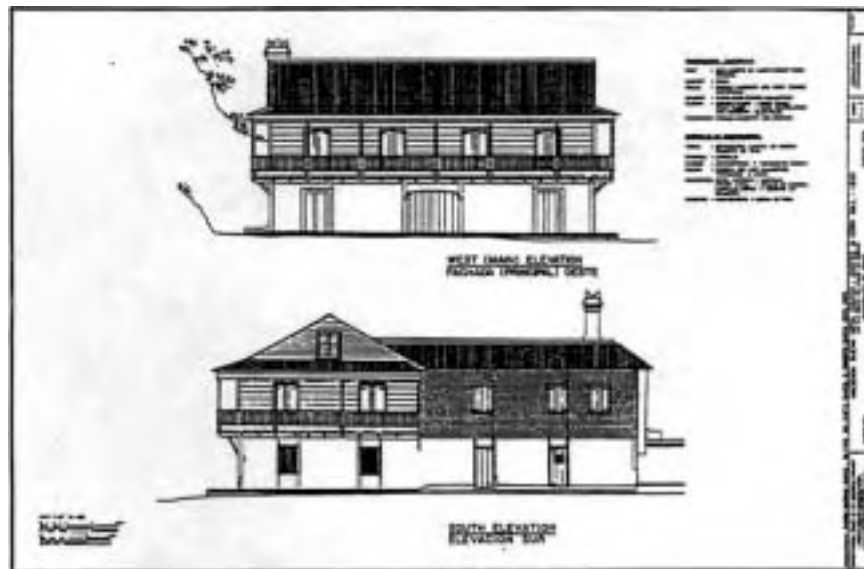
Elevations of Main House at Hacienda Buena Vista (1833) in Ponce, PR. (HAER 1986)

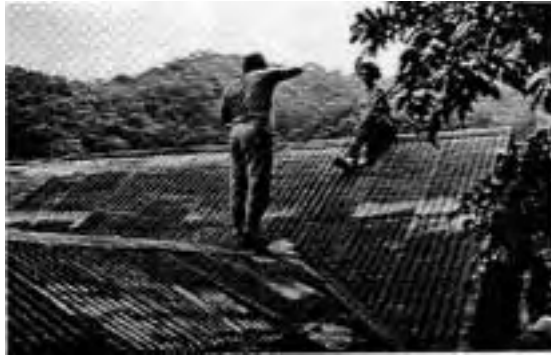
Main House roof documentation at Hacienda Buena Vista in Ponce, PR (1986).

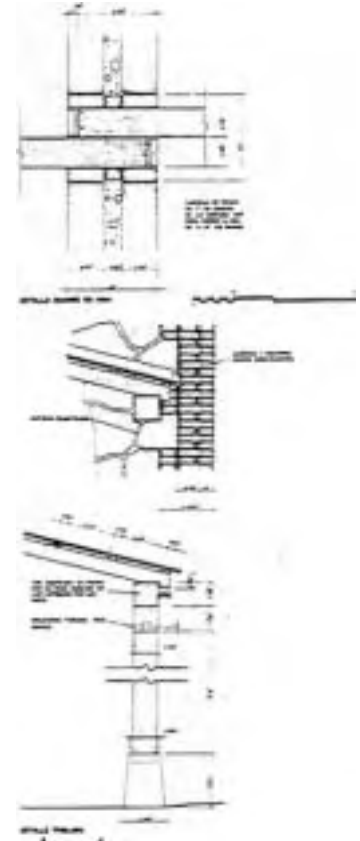
Documentation of traditional construction details (rubble masonry with specially cut stone components, bricks and wood).
Documentation Project of Casa de Camiero, Aibonito, PR (1997)

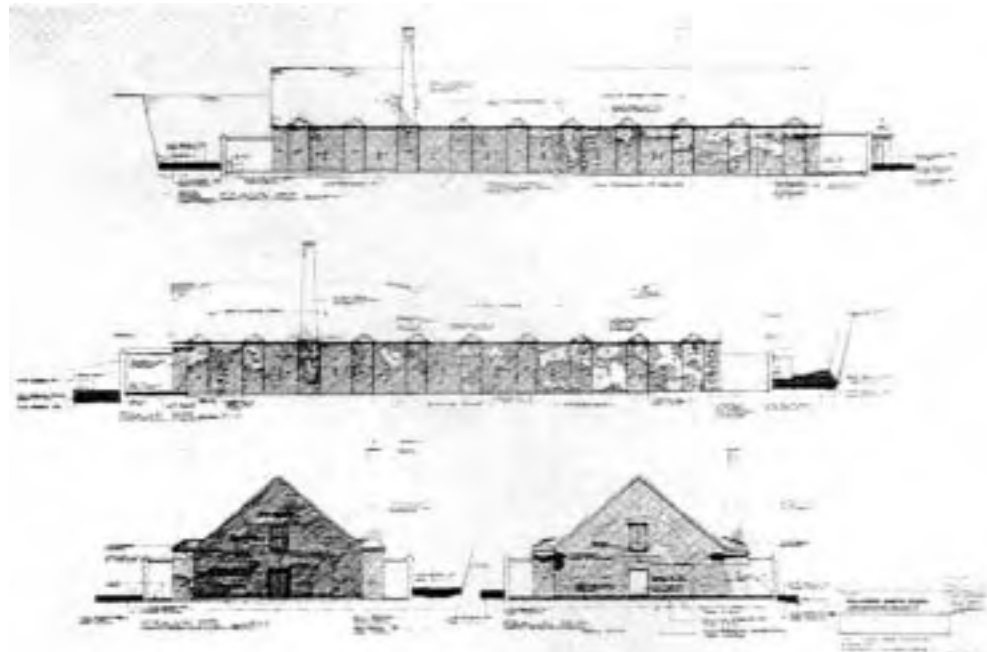
Condition survey drawings for the Polvorín de Santa Elena (1782) on El Motto grounds in Old San Juan, PR. (Otto O. Reyes Cassanova, AIA, Architects, 1991)

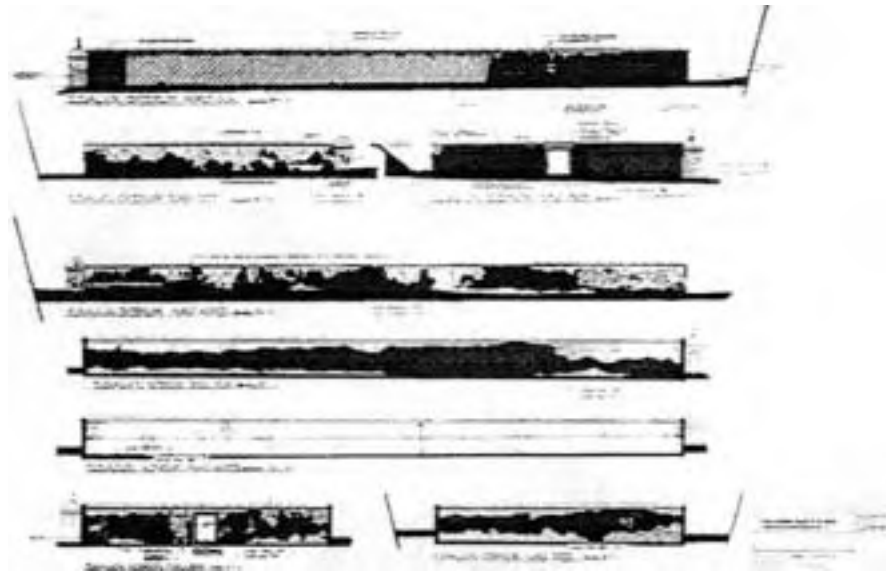
Condition survey drawings for the Polyorin tie Santa Elena (1782) on El Motto grounds in Old San Juan, PR. (Otto O. Reyes Cassanova. AIA. Architects. 1991)

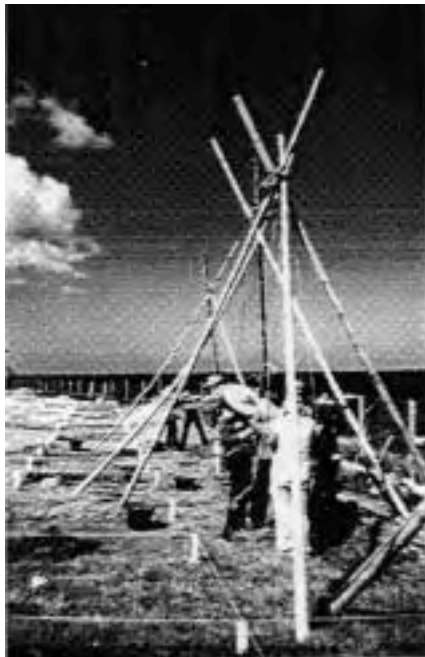
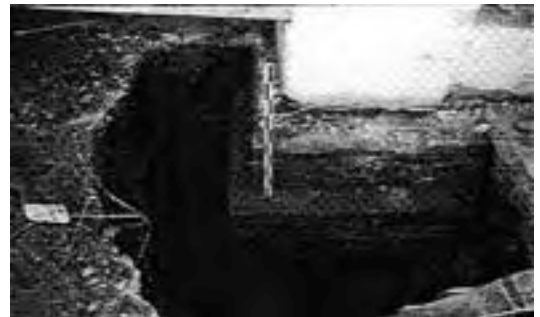
Archaeological excavation of footing at Ballajá Military Barracks (1990).

Archaeological excavations of Precolumbian and Spanish colonial remains in Puerta de Tierra, PR (1976).

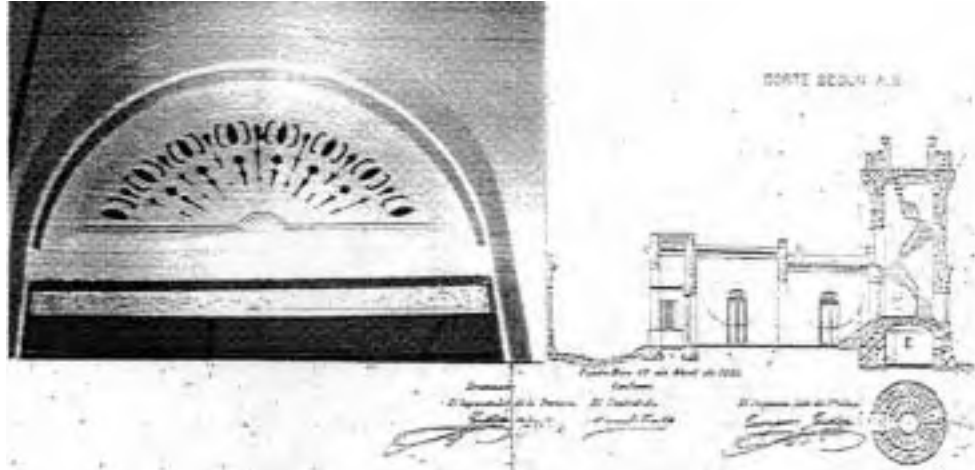
Part of inspection report of lighthouse at Las Cabezas tic San Tuan in Fajardo, PR which compares historic drawings to actual constructed details (1988).

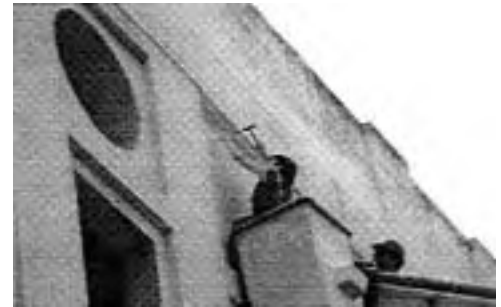
Ballajá Barracks material sampling from a high area of the building to assure least altered surfaces (1986). Done with the help of a "cherry picker" from the Electric Energy Authority

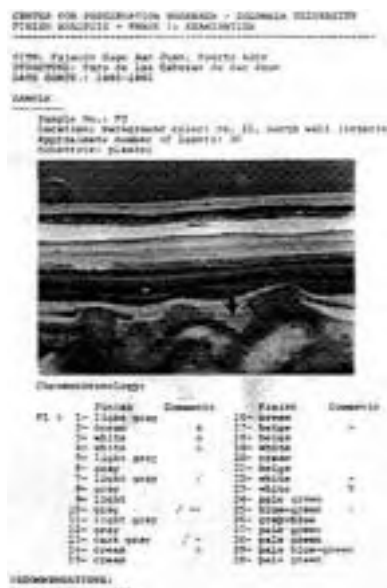
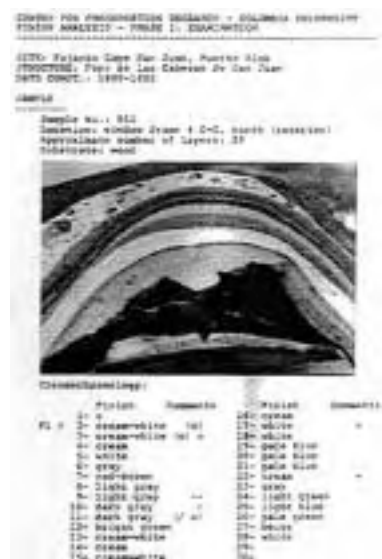
Color stratigraphies or chromochronologies as seen through a microscope. P3 gives the background color for a plaster surface while P12 gives the color of a wood window frame. Lighthouse at Las Cabezas de San Juan at Fajardo, PR (1988).

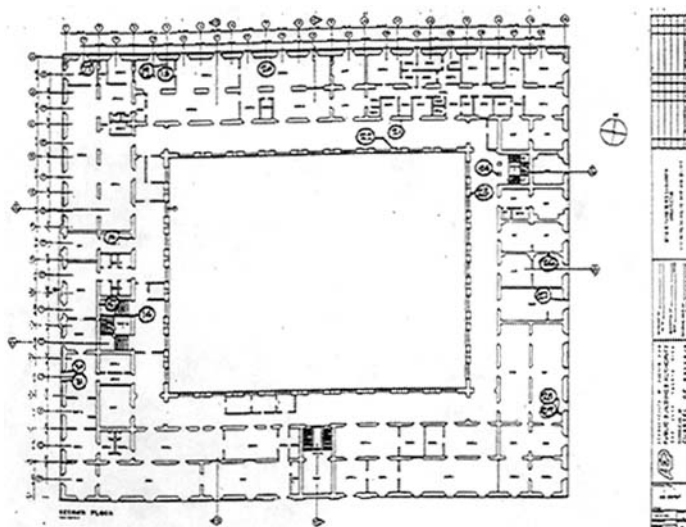
Sample extraction locations. Ballajá Baracks, Old San Juan, PR (1987).

Each sample should correspond to a photograph and graphic location on a drawing; this is done for location as well as to be able to retrace chronology of sampling procedure.

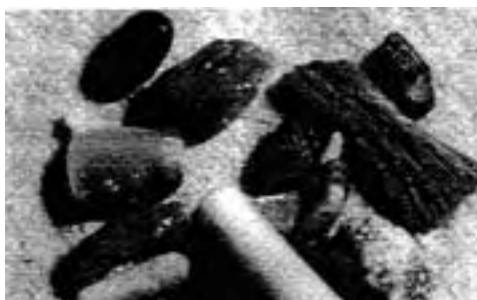
Magnified view of sand sample showing coral, shell, stone and wood from mortar analysis done in Ballajá Barracks Scientific Laboratory (1986)

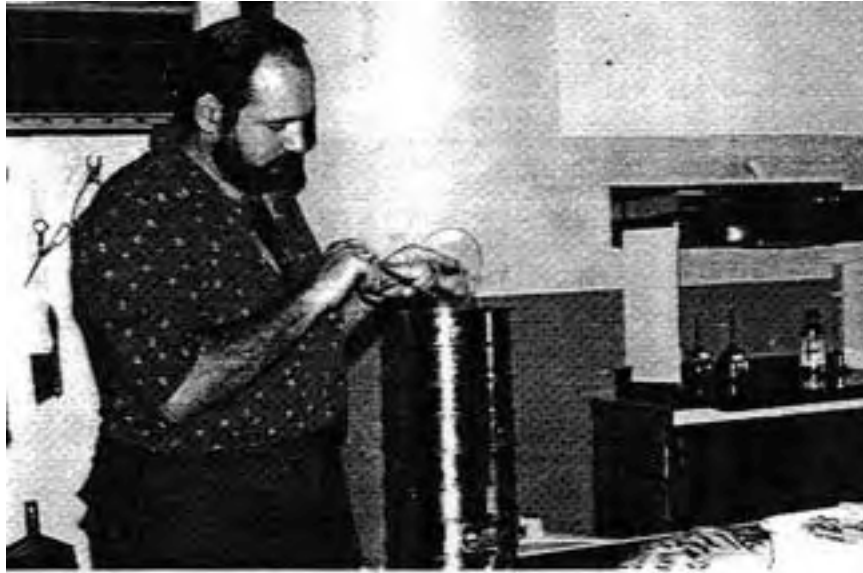
Sands are sifted for particle size analysis through grading of fines. Ballajá Barracks Scientific Laboratory (1986).

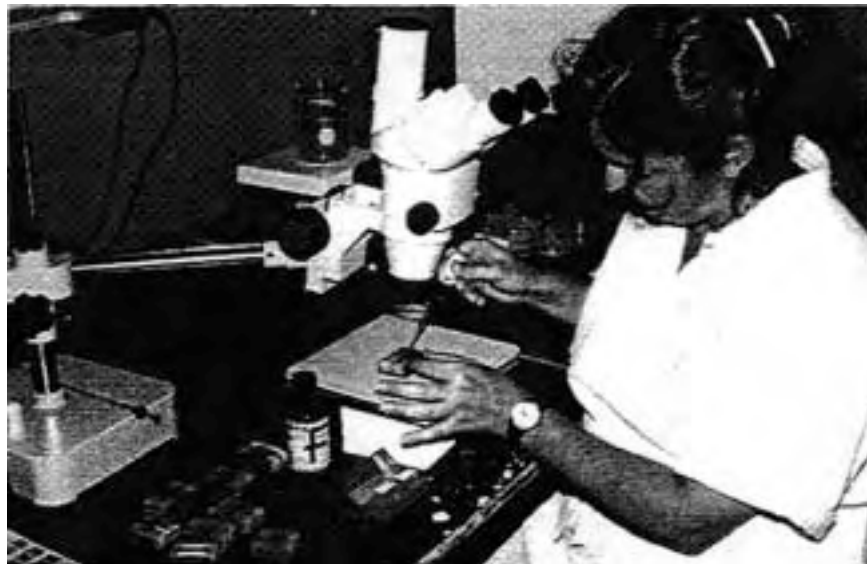
Color stratigraphy samples are mounted in resin, then polished for microscopic identification. Ballajá Barracks Scientific Laboratory (1986)

Through visual examination of the samples selected under the microscope the different type of paint layers applied to the building surfaces were identified, as well as the order in which they were applied to the buildings. This analysis made the reproduction of these colors and finishes possible and the chromatic restoration of the surfaces a reality. The end result of this process was the faithful reproduction of the original color schemes and textures of the main house. Interesting conclusions to the analysis demonstrated that the original rear facade was pink while the rest of the house was white-washed. Even though this was unusual by our present-day standards, it allowed us to better understand the practices of the period and present these realities to the visiting public in a visual form.

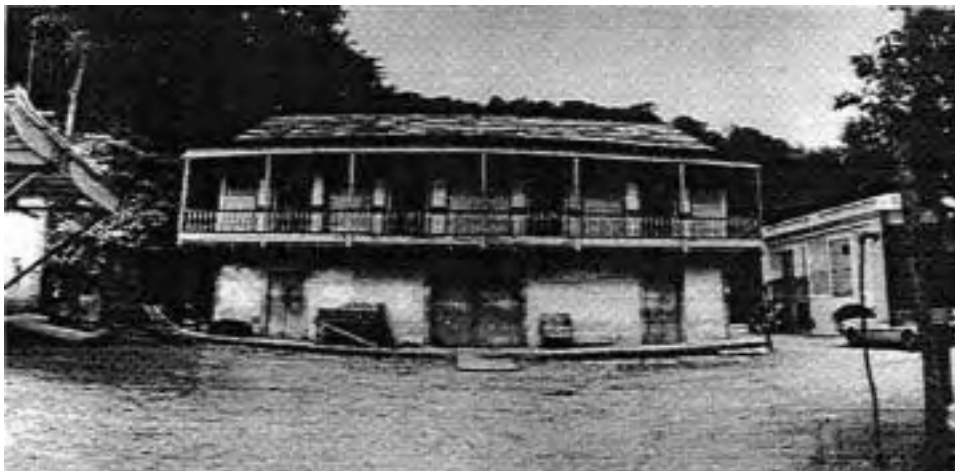
Hacienda Buena Vista Main House before restoration. Ponce, PR (1986).

Answers Sought: Due to the extreme degree of decay to the building surfaces principally as a consequence of their age, most of the plasters, shingles and wooden siding of these historic rubble-masonry and wooden structures had to be replaced. Original color schemes had been covered over the years. It was deemed important to try to identify these in order for the present intervention to be as faithful as possible in the recreation of the complete ambiance of an epoch. Of extreme importance then, were the establishment and reproduction of the original colors and finishes. It is important to understand that it is essential to utilize not only correct colors but correct surface finishes in conservation work (eg. Acrylic emulsion paint is not the same as limewash). The finish used for the conservation work need not be exactly the same as the original but should be similar in nature, properties and behavior.

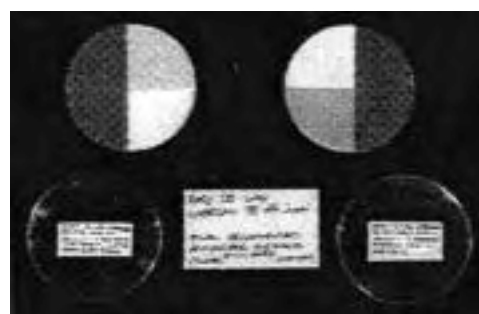
Final recommended compatible surface finishes (plaster and lime washes). Lighthouse at Las Cabezas de San Juan in Fajardo, PR (1988).

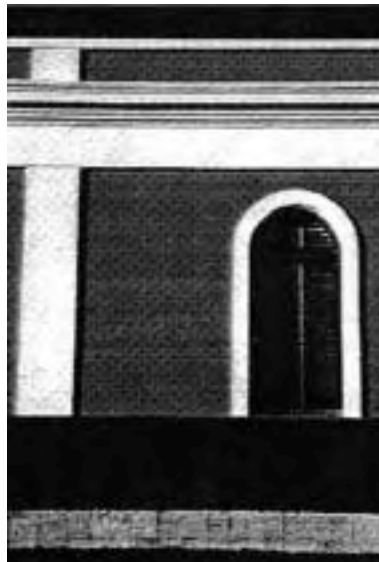
Detail of side facade showing final result of compatible finishes for plasters and lime washes. Lighthouse at Las Cabezas de San Juan in Fajardo, PR (1991).

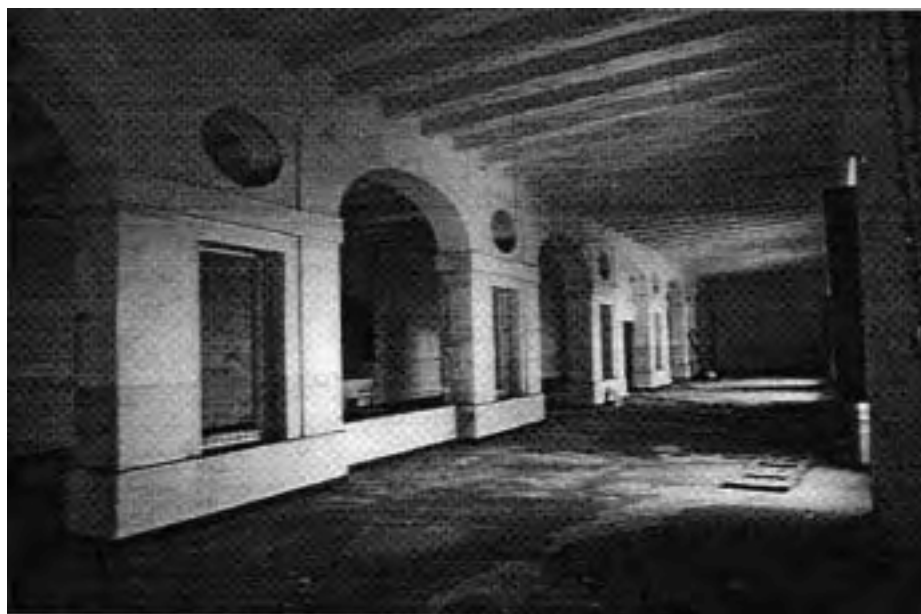
Interior view of a second-floor space within Ballajá Military Barracks in Old San Juan, PR, before intervention (1987).

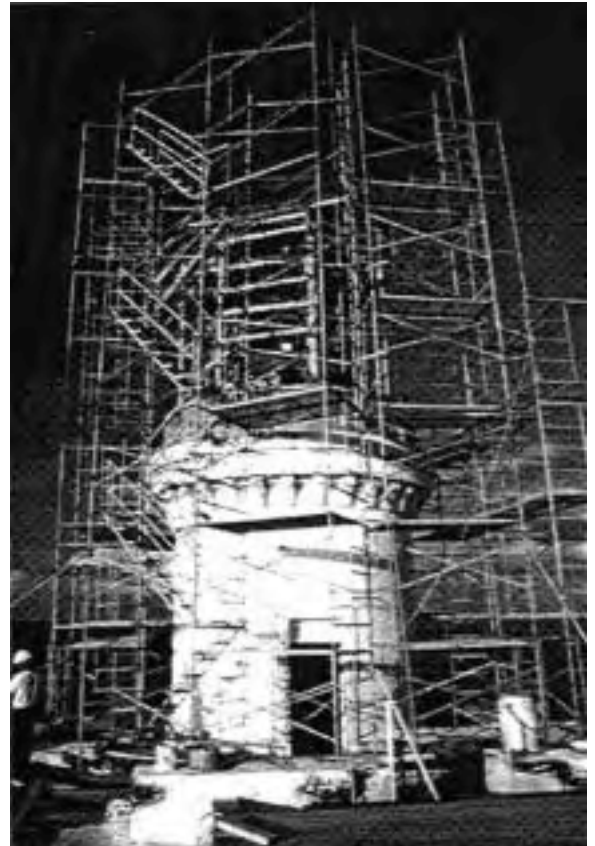
Restoration of the lighthouse tower at Las Cabezas de San Juan in Faiardo, PR (1990)

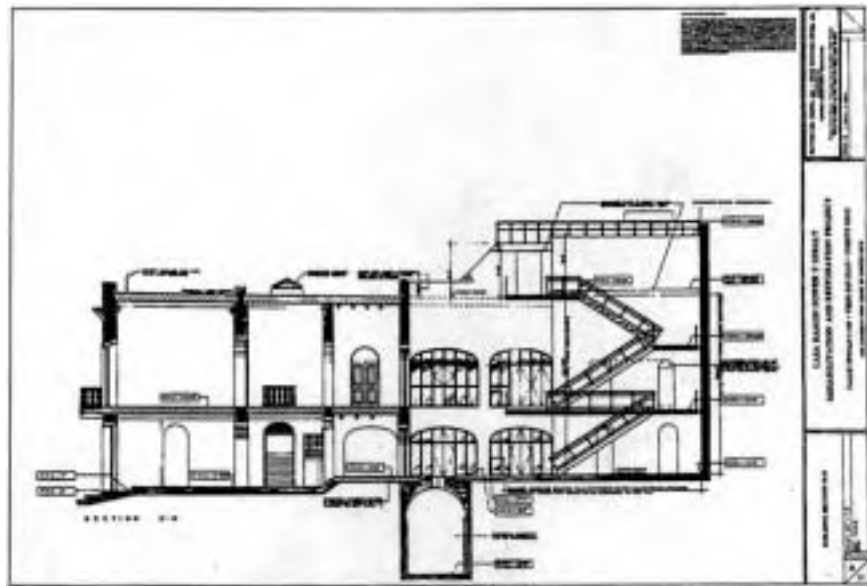
Longitudinal section through Casa Ramón Power y Giralt showing proposed interventions (1993). Beatriz del Cueto and Otto O. Reyes Cassanova, Architects and Historic Preservation Consultants.

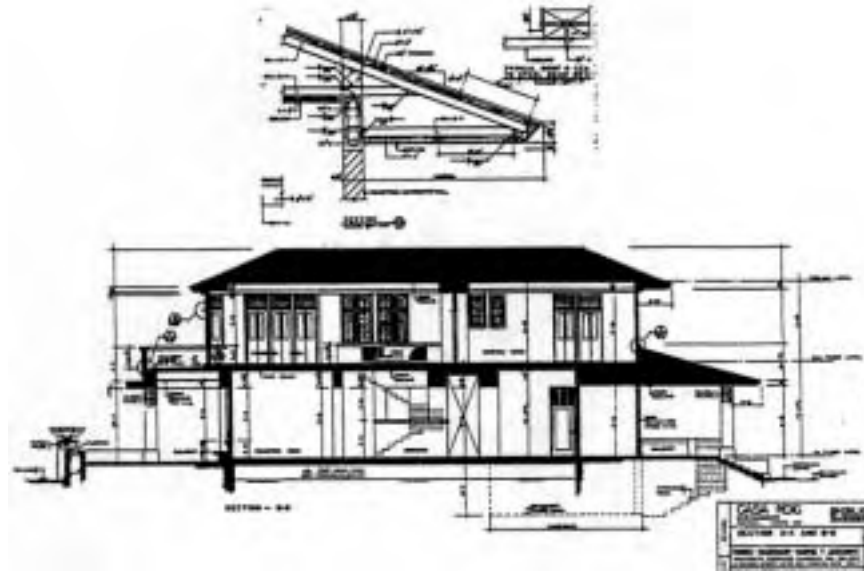
Building section and detail of Casa Roig showing connections between new steel roof truss and interior traditional finishes. Humacao, PR (1985). Torres, Beauchamp, Marvel y Asociados with Otto O. Reyes, Architects.

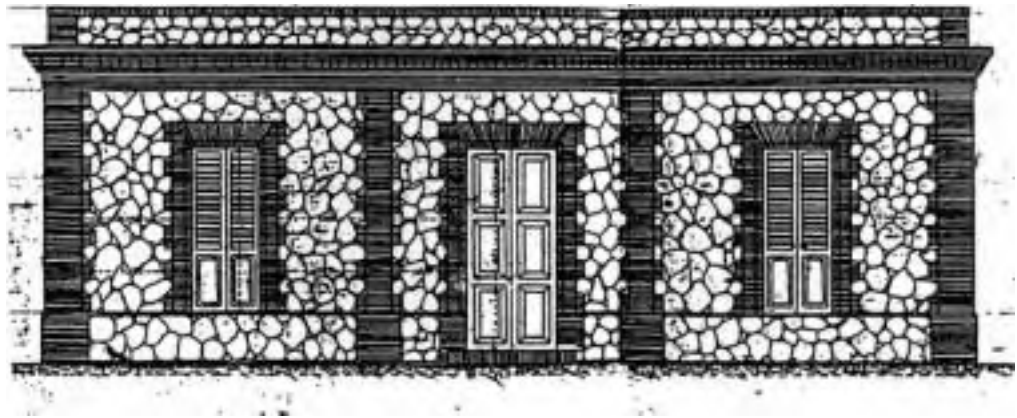
Casa de caminero with exposed cut stone construction (1888) in Puerto Rico.

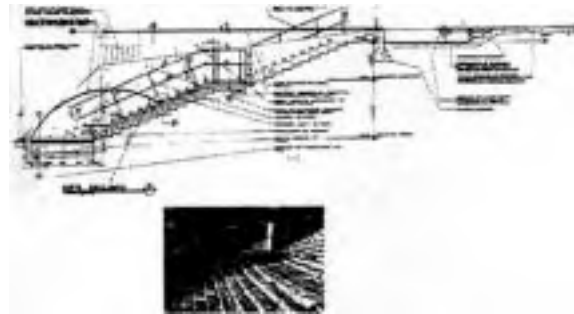
Old cemetery restoration in Mayagüez, PR, where historic stairs were stabilized while two steel side stairs were “floated” over the historic fabric to comply with contemporary safety codes and requirements. Rigau + Penabad, Architects (1994).

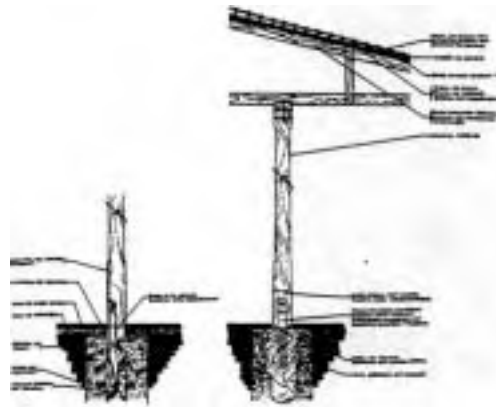
Restoration work carried out in Porta Coeli Church in San German, PR, to stabilize the structural members and replace the existing non-traditional roof with Royal Palm wood planks for the interior ceiling and knee ceramic tile for the exterior covering. Izquierdo, Rueda & Associates with the ESCO Group (1996).

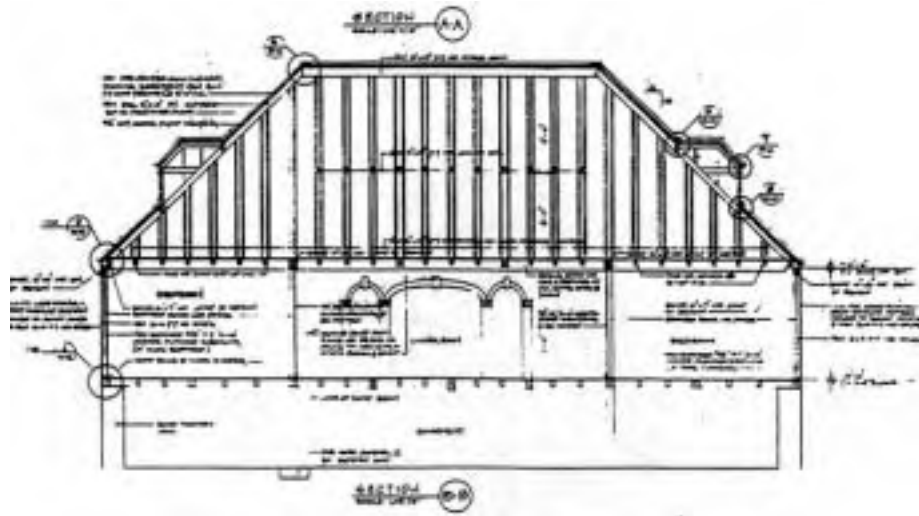
Annaly House Reconstruction Project section at Estate Annaly in St. Croix, USVI. Chaljub – Lanio Architects, Inc. (1990)

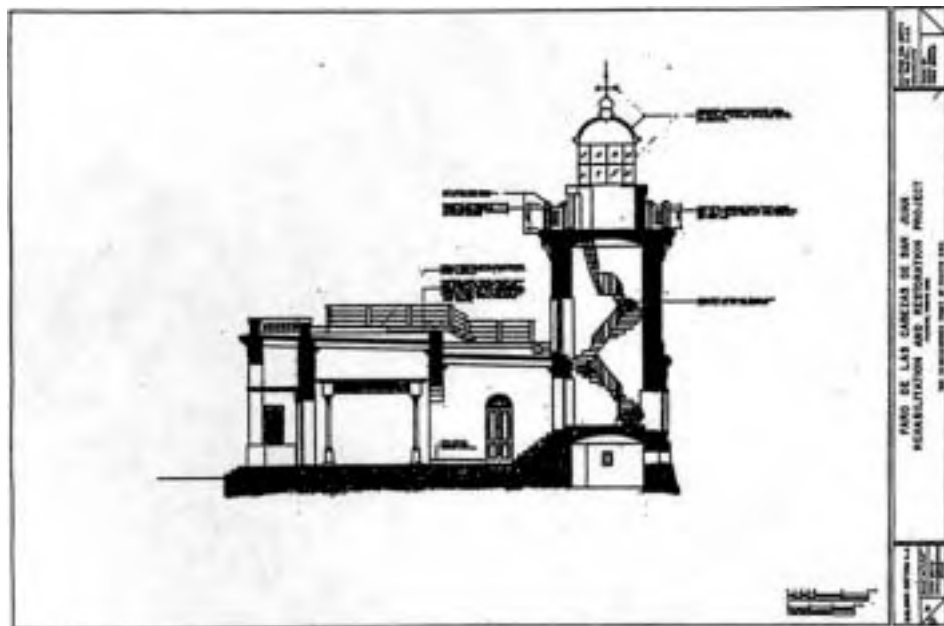
Longitudinal section through historic lighthouse at Las Cabezas de San Juan at Fajardo, PR, showing present interventions, specifically the addition of a wooden steel deck on the rooftop as an observation deck for visitors. Beatriz del Cueto de Pantel, AIA. (1990)

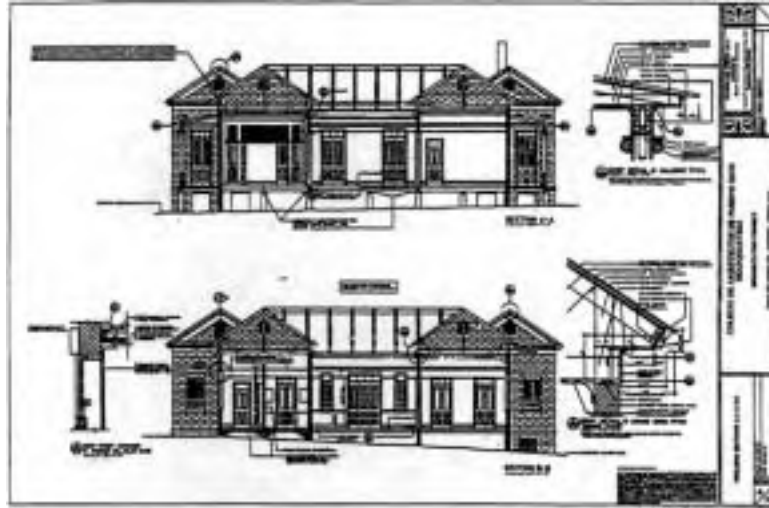
Sections and details through the Colegio de Arquitectos de Puerto Rico Rehabilitation Project in Santurce, PR. Beatriz del Cueto, AIA, Architects and Historic Preservation Consultants (1992).

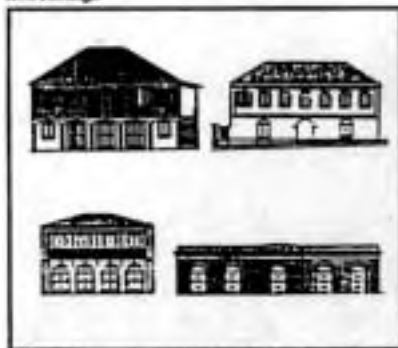
Roof form is important to historic buildings. Every effort must be made to retain the shape and minimum of historic finish.

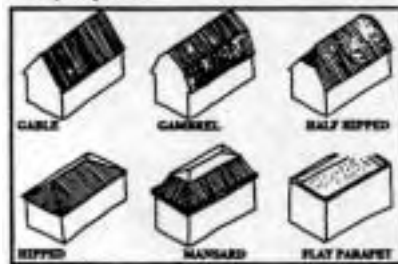
The range of roof types.

Most roofs in the Virgin Islands are "hipped", that is, a roof of four intersecting planes. Occasionally these rise to a single point, but more often are topped by a ridge line running parallel (though sometimes perpendicular) to the street. A few roofs are gable-ended. A few combine these elements with "half-hipped" forms. Others, such as Mansard roofs (right-angled), are truly exceptions.

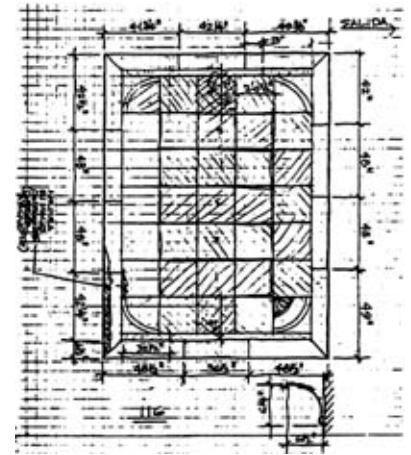
Existing condition field sketch of historic tin ceiling prior to restoration work. Colegio de Arquitectos de Puerto Rico (1992).

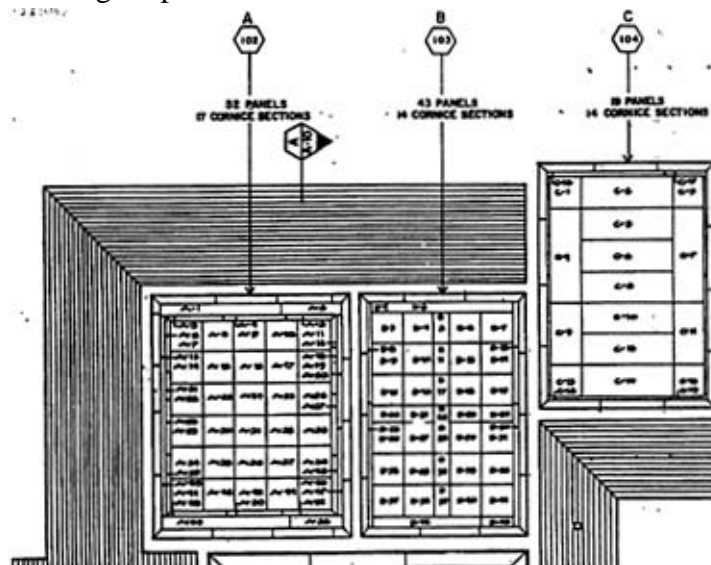
Construction drawing detail of reflected ceiling plan which enumerates individual tin ceiling panels for dismantling and re-assembling purposes. Colegio de Arquitectos de Puerto Rico Rehabilitation Project (1992).

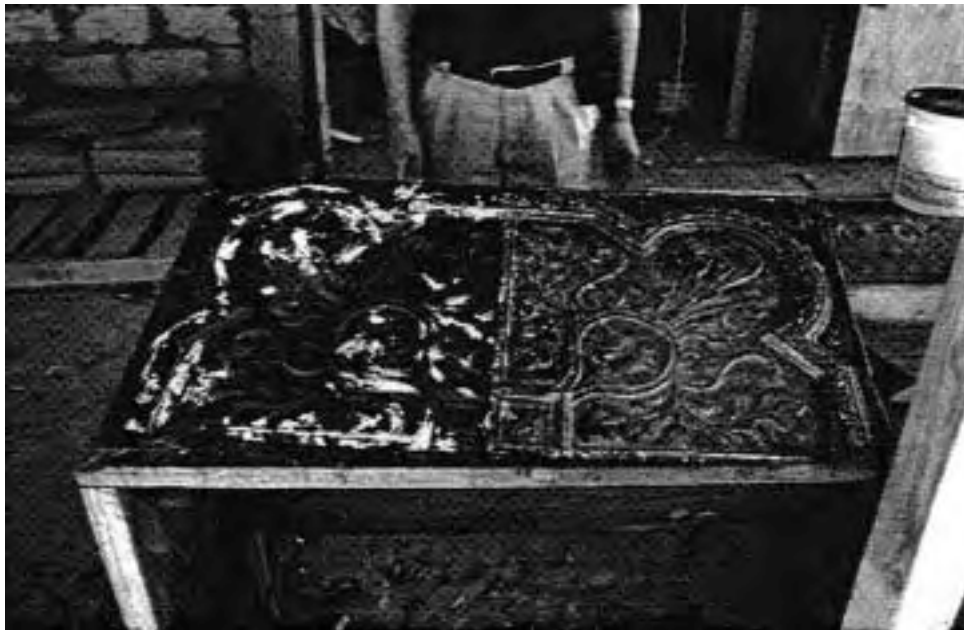
Original (left) and fiberglass reproduction (right) of tin ceiling panels. The original historic examples in good condition were used as molds where replacement panels were needed. Colegio de Arquitectos de Rico Rehabilitation Project (1992).

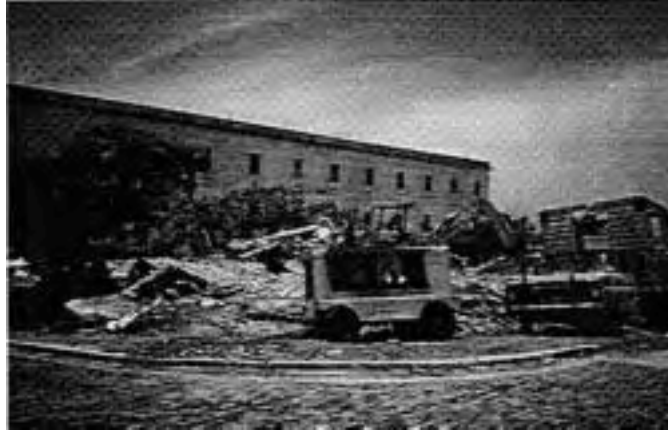
Demolition of existing structures for Plaza Quinto Centenario in Ballajá District of Old San Juan, PR (1986).

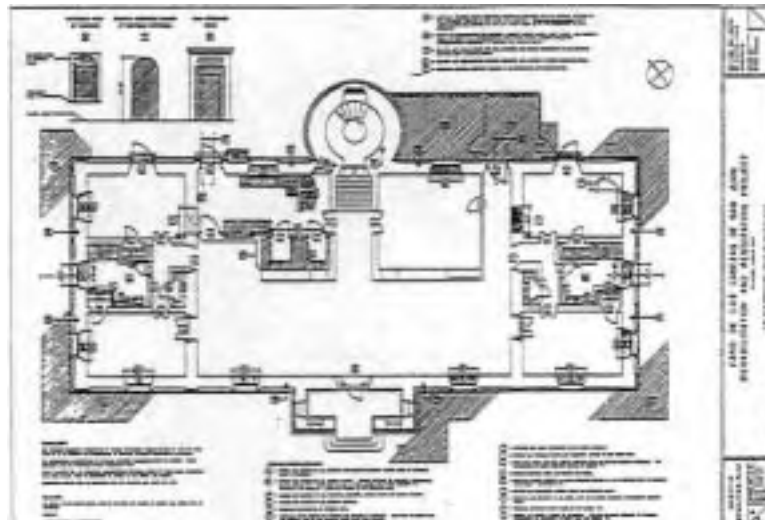
Selective demolition plan for the Faro de Las Cabezas de San Juan Rehabilitation and Restoration Project in Fajardo, PR (1989)

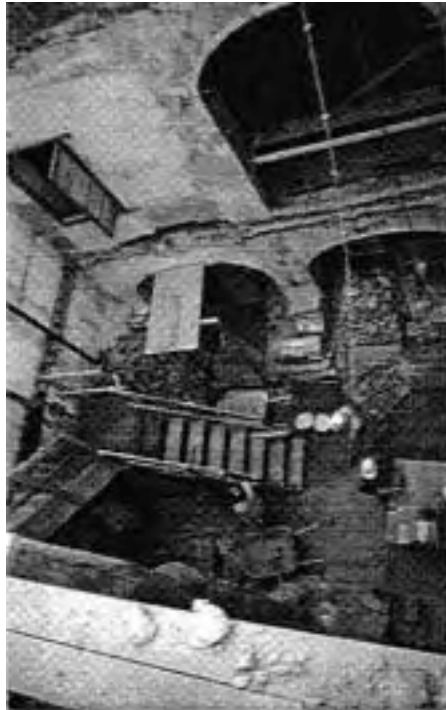
Interior patio at Casa Ramón Power y Giralt during selective demolition work in Old San Juan. PR (1994).

After all the information has been included in the set of drawings, the first and most important step is to collect any loose historic construction material found at the site that has already detached itself from its place of origin. These may be balusters, beams or roofing brick, among others. These should be inventoried, classified, and stored in a safe and dry place until ready to be re-utilized.
