**A MANUAL ON CONSERVATION
METHODOLOGY
FOR HISTORIC BUILDINGS & STRUCTURES**

Puerto Rico and the Virgin Islands

US Department of the Interior
National Park Service
National Center for
Preservation Technology and Training
Publication No. 1997-07

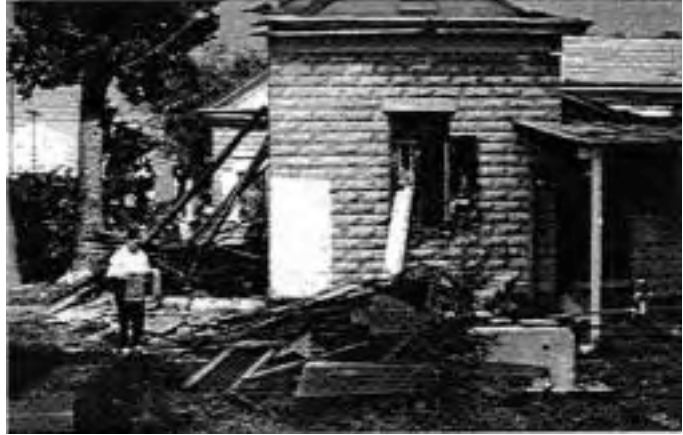
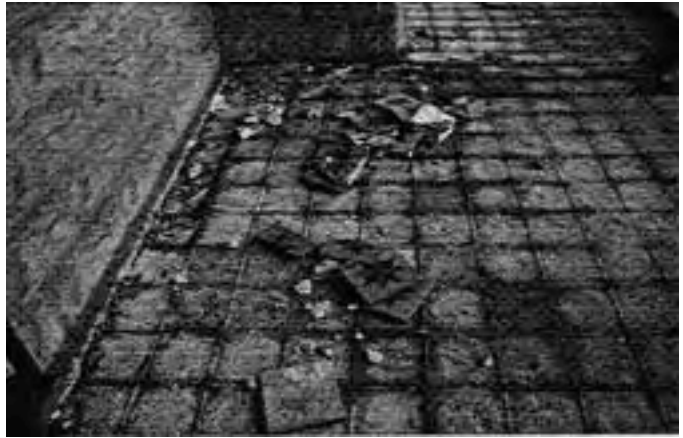
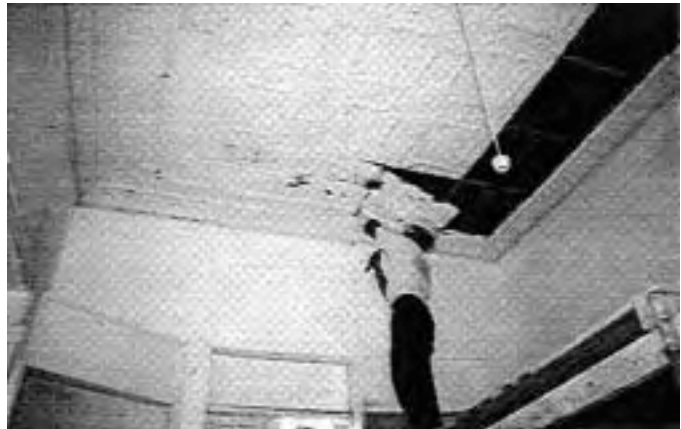
Interior patio at Casa Ramón Power y Giralt during selective demolition work in Old San Juan. PR (1994).

Roof, flooring, and tin ceiling dismantling work at Colegio de Arquitectos de Puerto Rico Headquarters restoration following selective demolition specifications. (1993)

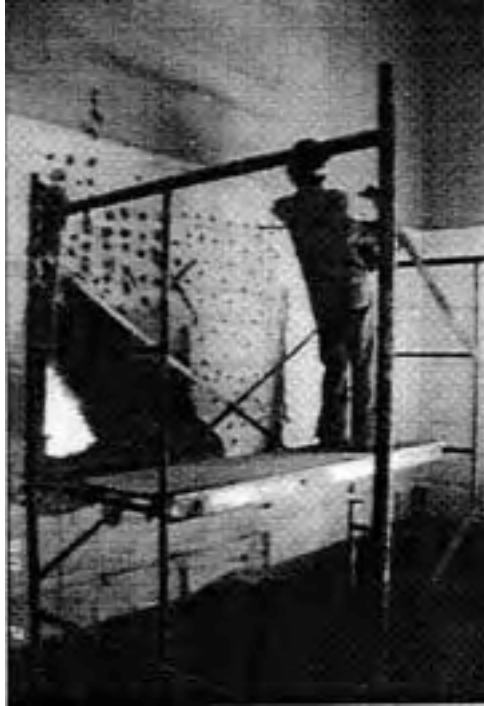
Drilling reinforced concrete wall before removal from adjacent historic fabric in Ballajá Military Barracks in Old San Juan, PR (1988).

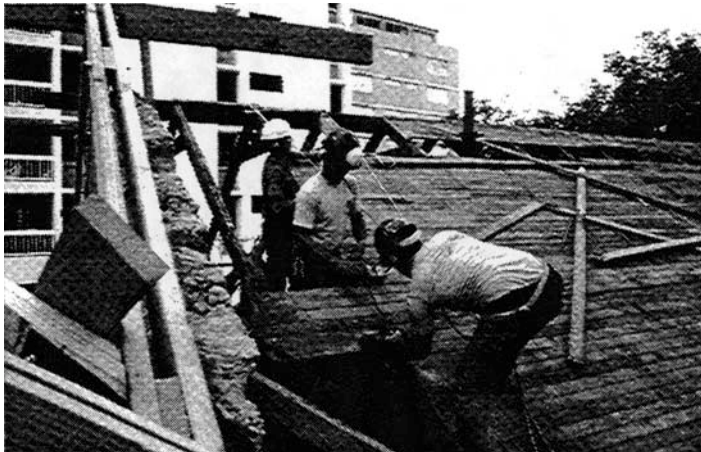
Cutting wood boards before dismantling original roof truss during Colegio de Arquitectos Headquarters restoration in Santurce, PR (19931).

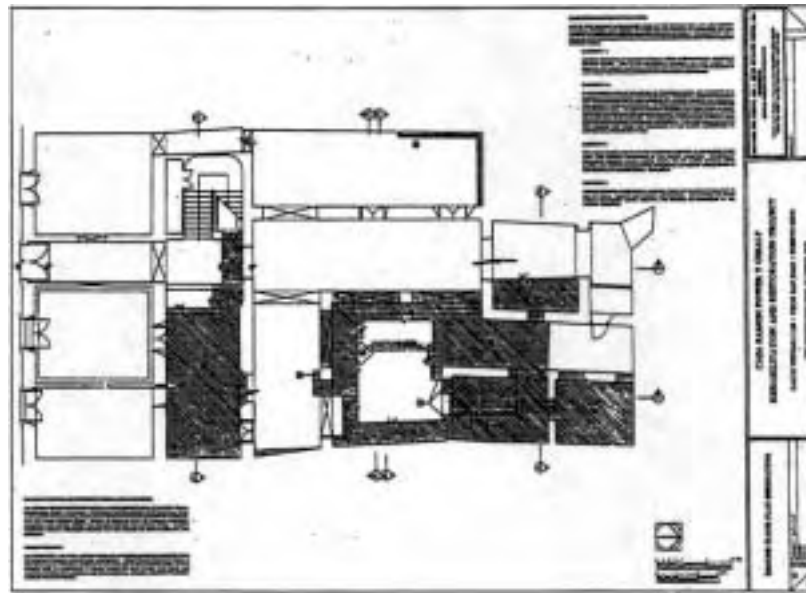
Selective demolition plan for Casa Ramón Power y Giralt as future headquarters for the Conservation Trust of Puerto Rico (1993).

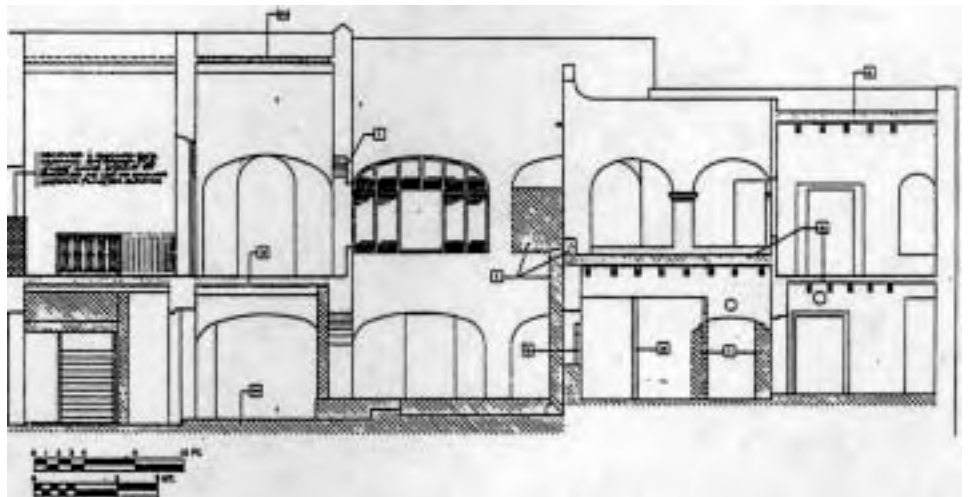
Partial section drawing for selective demolition phase of Casa Ramón Power y Giralt in Old San Juan, PR (1993).

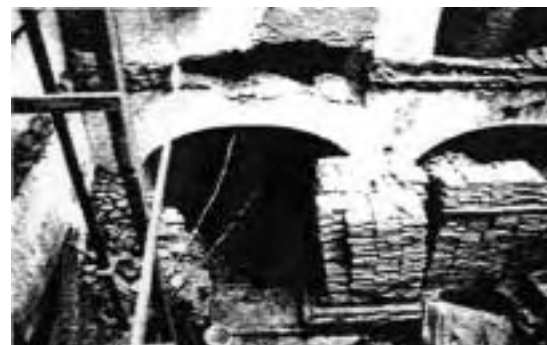
Storage of reusable historic brick conserved from dismantling and selective demolition phase of Casa Ramón Power y Giralt in Old San Juan, PR (1994).

be kept as surplus for other buildings of similar construction fabric or period in our region. The traditional construction materials and elements must then be cleaned, and stored in a safe place (away from falling objects and potential vandalism) and in a location that is kept dry. If there is an excessive amount of material to be stored, this should be kept on the outside project grounds, covered by plastic tarpaulins to keep water and sun away from them. Remember, one of the greatest dangers and cause of destruction to nearly all construction material is water. In other cases, arrangements should be made to transport the material away from the project site to a safe storage place during the clean-up phases. At this alternate site, some of these materials may be reconditioned, preserved or returned to a usable state.

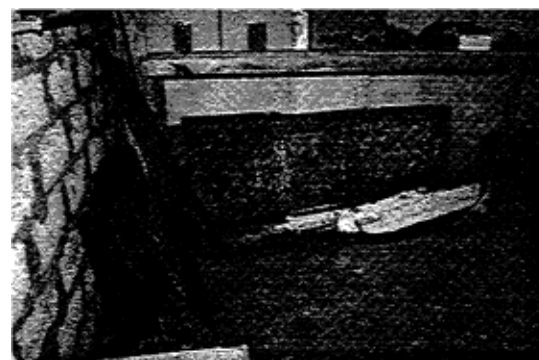
Cleaned historic tin ceiling panels being stored for restoration and future re-installation in the Colegio de Arquitectos de Puerto Rico Headquarters during restoration (1993).

In the case of individual elements, such as tin ceiling panels, intricately perforated wooden door transoms or marble stair risers and treads that must be restored and re-installed in their place of origin, the elements must be classified alpha-numerically, in-place, before removal for storage or restoration. Identification should be done utilizing indelible inks or paints or the materials must be tagged in such dismantling, transportation, or during an extended storage period. Cataloguing identification should be kept to a minimum size and if possible, should be done in an area of each element which can later be covered over or on an edge or side which will not show when re-installed. Care should be taken to not mark historic material in a location or in a way which will later be impossible to remove or conceal. Any cataloguing data should be transferred immediately to a set of As-Built drawings to assure original location information of a particular material. In the case of elements that can be recycled and replaced in an

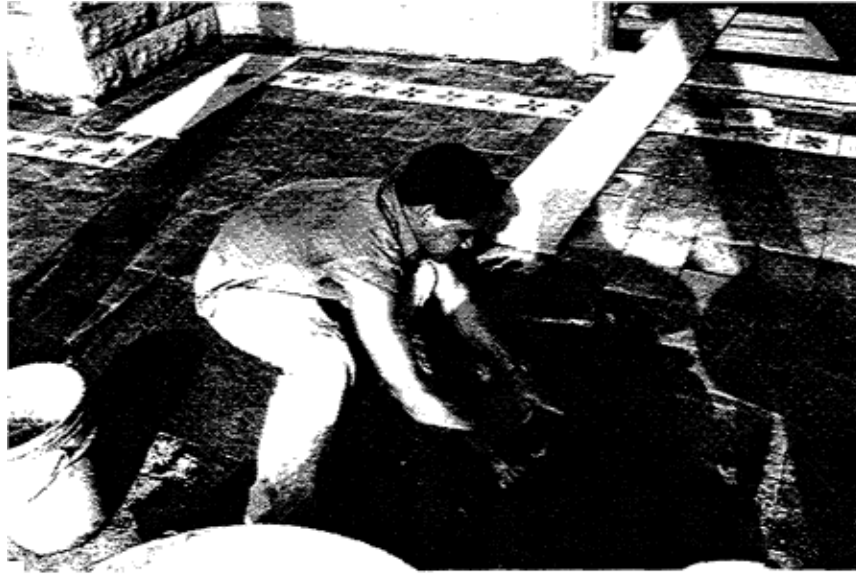
The majority of the original ornamental hydraulic-cement tiles (star-pattern) were saved and re-incorporated into the project, by utilizing new solid-color tiles of a similar composition to complete the square footage needed for restoration of the exterior floors. Colegio de Arquitectos de Puerto Rico Rehabilitation Project in Santurce, PR (1994).

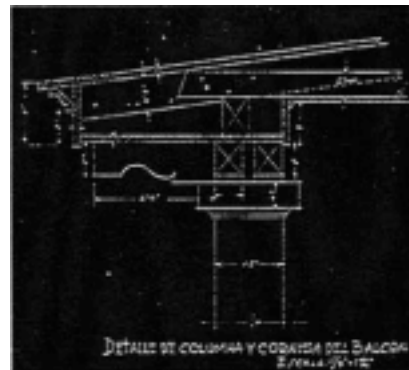
Balcony roof detail of the M. Godreau Residence (1919) in Ponce. PR (AMP)

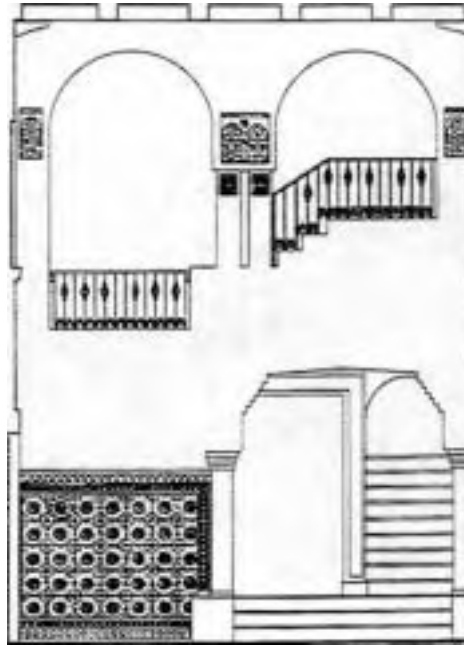
Vestibule facade detail, reconstructed from historic documentation, of the El Mundo/Puerto Rico Ilustrado Building (ca. 1924) in Old San Juan, PR (1996).

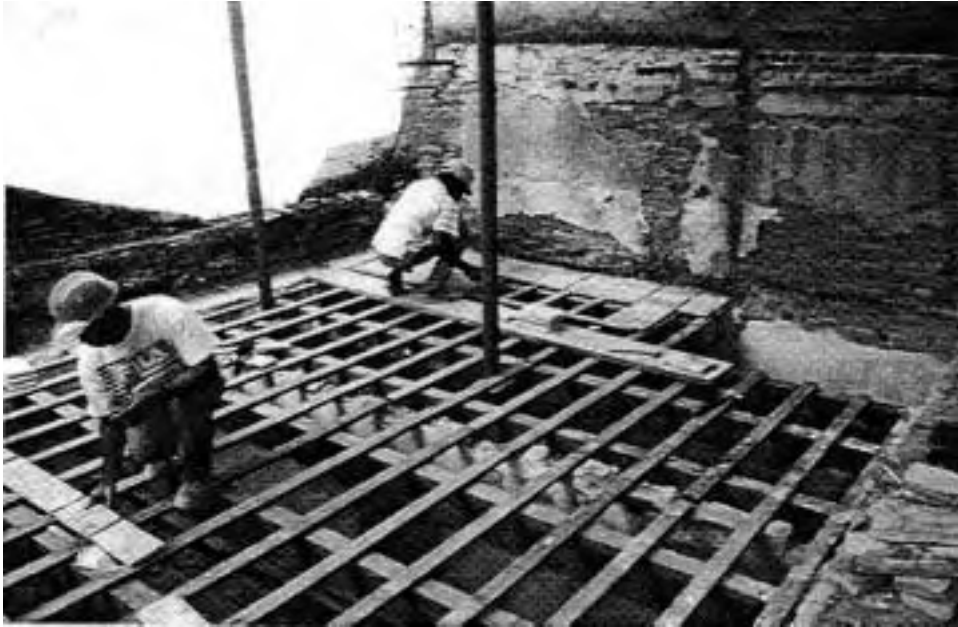
The reconstruction of the flat ceiling and roof utilizing recycled historic ausubo (bullet wood) roof beams, slats and brick in the Casa Ramón Power y Girth Restoration Project Old San Juan, PR (1994).

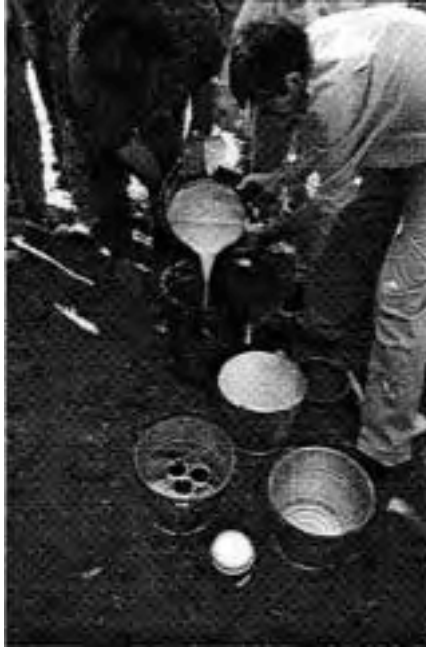
Architectural Conservator Frank Matero demonstrates traditional limewash production techniques at the Casa de Caminero project in Juana Diaz, PR. Design 203 architectural students during fieldwork exercises from the Polytechnic University of Puerto Rico (1997).

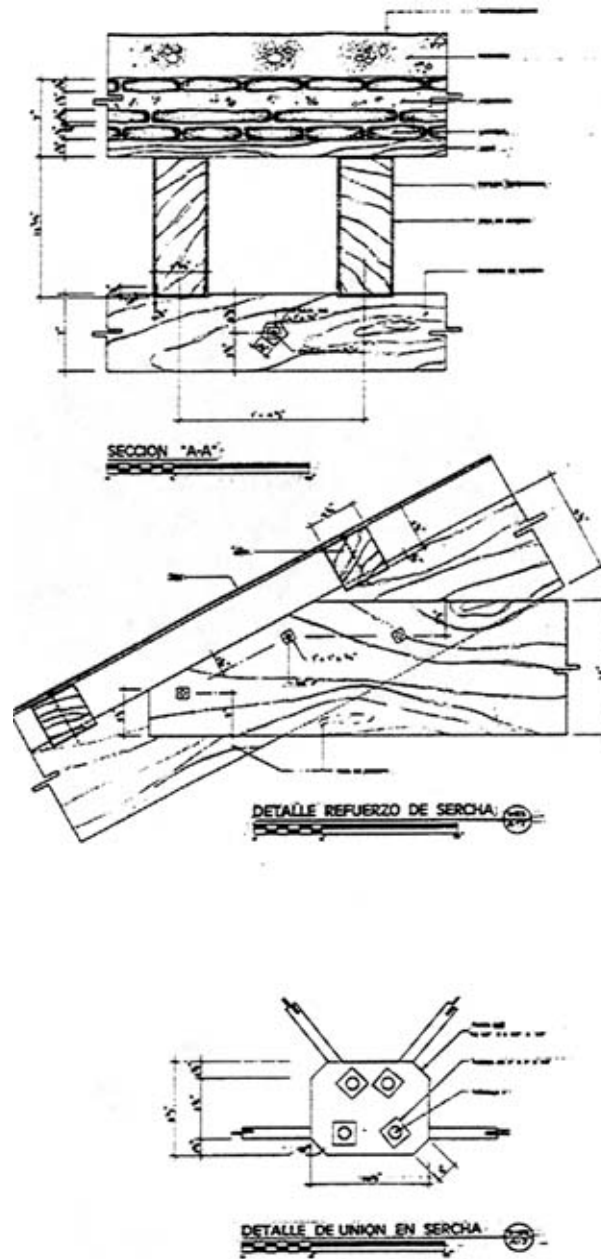
Details of traditional construction technology from the Humacao Customs House in Puerto Rico. Drawn by Design 203 Architectural Students of the Polytechnic University of Puerto Rico (1997).
